Access Compliance Report

Public Rights-of-Way

(Curb Ramps)

Intersection ID: 30121	Main Street: CLOONEY_LN	Cross Street: VERNON_WOOD_LN	Location: NE
ADA ID: 8DB0A1A58A8E	Ramp Type: Perpendicular Diagonal	Initial Pass/Fail: Fail	Overall Compliance: No
Severity Score: 21.25			
Codes/Mitigation Info/Possible Solution		Field Measurements/Component Compliance

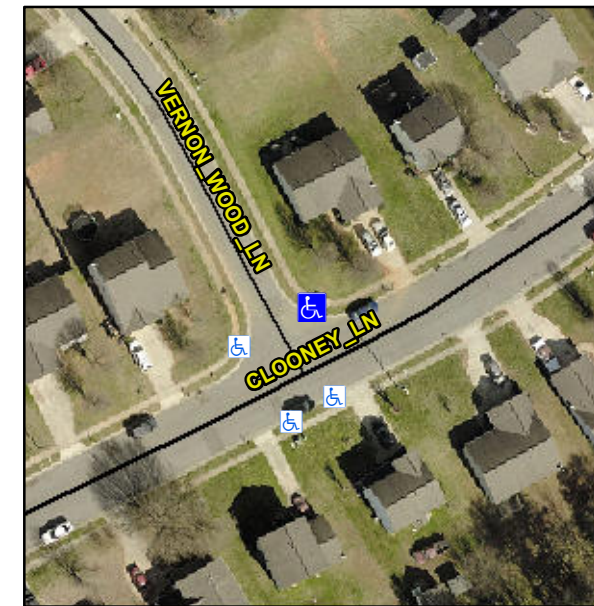
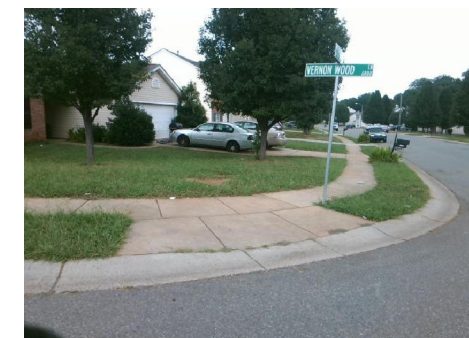
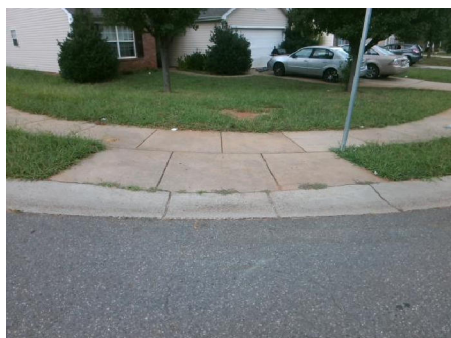
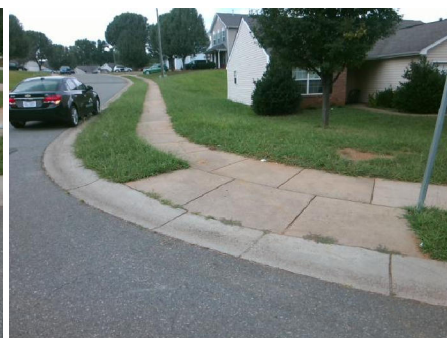
Not Found, R304.5.1, R304.5.3

Compliance	Description	Data	Compliance	Description	Data
N/A	Ramp Length (in)	50.0	Yes	Ramp Slope (%)	6.2
No	Ramp Width (in)	42.5	No	Ramp XSlope (%)	5.7
N/A	Flare Type LT	N/A	N/A	Flare Type RT	N/A
N/A	Flare Slope LT (%)	N/A	N/A	Flare Slope RT (%)	N/A
N/A	Flare Traversable LT?	N/A	N/A	Flare Traversable RT?	N/A
N/A	Landing Length (in)	N/A	N/A	DWS Provided?	N/A
N/A	Landing Width (in)	N/A	N/A	DWS Contrast?	N/A
N/A	Landing Slope (%)	N/A	N/A	DWS Length (in)	N/A
N/A	Landing X Slope (%)	N/A	N/A	DWS Full Width?	N/A
N/A	Landing Curb? (Y/N)	N/A	N/A	DWS Offset (in)	N/A
N/A	Shared Landing?	N/A			
N/A	Gutter Ponding?	N/A	N/A	Gutter Slope (%)	N/A
N/A	Gutter Lip Ht (in)	N/A	N/A	Gutter X Slope (%)	N/A
N/A	Painted X Walk1?	No	N/A	Painted X Walk2?	No
	X Walk 1 Direction	To W		X Walk 2 Direction	To S
N/A	X Walk 1 Width (in)	N/A	N/A	X Walk 2 Width (in)	N/A
	X Walk 1 Slope (%)	3.3		X Walk 2 Slope (%)	1.4
	X Walk 1 X Slope (%)	2.8		X Walk 2 X Slope (%)	2.3

N/A	Ramp inside XWalk1?	N/A	N/A	Ramp inside XWalk2?	N/A
	Road Slope (%)	3.1	N/A	Clear Space?	N/A
	Road X Slope (%)	0.3	N/A	Clear Space to XWalk (in)	N/A
N/A	Any Obstructions?	N/A	N/A	Storm Grate/Utility Hazard?	N/A
	Obstruction Type			Storm Grate/Utility Type	
		N/A			N/A
			Yes	Surface Condition? (G/P)	Good

Remove & Replace Curb Ramp With Two New Directional Ramps or Equivalent.
