Access Compliance Report Public Rights-of-Way (Curb Ramps)

Intersection ID: 12257 Main Street: W 3RD ST Cross Street: S_POPLAR_ST Location: **Overall Compliance: No ADA ID: 8DB53AC4E877** Ramp Type: Perpendicular Diagonal Initial Pass/Fail: Fail Severity Score: 21.25

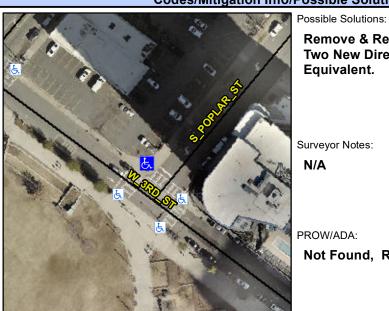
Field Measurements/Component Compliance							
Compli	ance Description	Data	Compl	liance	Description	Data	
N/A	Ramp Length (in)	120.0	Yes	Ramp	Slope (%)	5.9	
No	Ramp Width (in)	46.5	No	Ramp	XSlope (%)	5.8	
N/A	Flare Type LT	N/A	N/A	Flare	Type RT	N/A	
N/A	Flare Slope LT (%)	N/A	N/A	Flare	Slope RT (%)	N/A	
N/A	Flare Traversable LT?	N/A	N/A	Flare	Traversable RT?	N/A	
N/A	Landing Length (in)	N/A	N/A	DWS	Provided?	N/A	
N/A	Landing Width (in)	N/A	N/A	DWS	Contrast?	N/A	
N/A	Landing Slope (%)	N/A	N/A	DWS	Length (in)	N/A	
N/A	Landing X Slope (%)	N/A	N/A	DWS	Full Width?	N/A	
N/A	Landing Curb? (Y/N)	N/A	N/A	DWS	Offset (in)	N/A	
N/A	Shared Landing?	N/A					
N/A	Gutter Ponding?	N/A	N/A	Gutte	r Slope (%)	N/A	
N/A	Gutter Lip Ht (in)	N/A	N/A	Gutte	r X Slope (%)	N/A	
N/A	Painted X Walk1?	Yes	N/A	Paint	ed X Walk2?	Yes	
	X Walk 1 Direction	To SW		X Wa	lk 2 Direction	To SE	
N/A	X Walk 1 Width (in)	161.0	N/A	X Wa	lk 2 Width (in)	113.0

X Walk 1 Slope (%)	3.8		X Wa	lk 2 Slope (%)	4.4	
	X Walk 1 X Slope (%)	4.0		X Wa	lk 2 X Slope (%)	4.1	
N/A	Ramp inside XWalk1?	Yes	N/A	Ramp	inside XWalk2?	Yes	
	Road Slope (%)	4.8	N/A	Clear	Space?	N/A	
	Road X Slope (%)	1.4	N/A	Clear	Space to XWalk (in)	N/A	
N/A	Any Obstructions?	N/A	N/A	Storm	Grate/Utility Hazard?	N/A	
	Obstruction Type			Storm	n Grate/Utility Type		
		N/A				N/A	
			Yes	Surfa	ce Condition? (G/P)	Good

W 3RD ST Street 1 Name Stop Condition-Street 2 Signal **S POPLAR ST** Street 2 Name Stop Condition-Street 1 Signal Remove & Replace Curb Ramp With Two New Directional Ramps or Equivalent.
