# Access Compliance Report

### (Curb Ramps)

| Intersection ID: N/A | Main Street: ARBOR_LOOP_DR | Cross Street: POTOMAC_RIVER_PY | Location: NW |
| ADA ID: 8DB8E69D1ED5 | Ramp Type: Directional | Initial Pass/Fail: Pass | Overall Compliance: No |

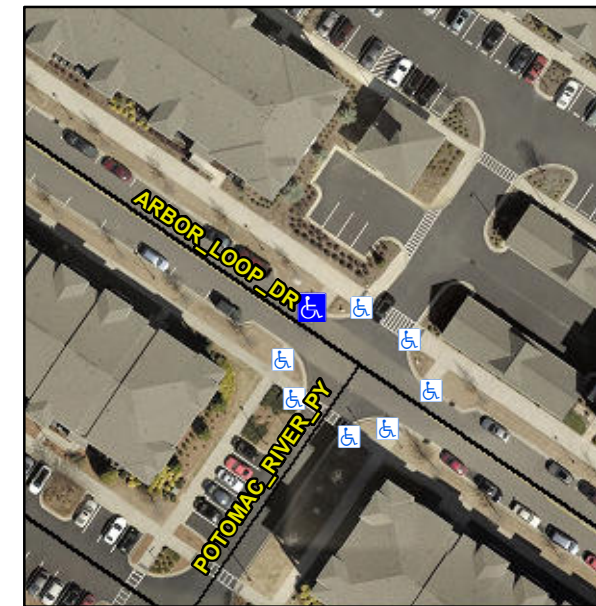
#### Field Measurements/Component Compliance

**R304.5.3**

| Compliance | Description | Data | Compliance | Description | Data |
|---|---|---|---|---|---|
| Yes | Ramp Width (in) | 82.0 | No | Grade Break Slope (%) | 5.8 |
| No | Ramp XSlope (%) | 3.6 | | | |
| Yes | Gutter Lip Ht (in) | 0.0 | No | Gutter X Slope (%) | 4.7 |

Possible Solutions:

**Remove & Replace Entire Ramp.**  
**Remove & Replace Gutter.**
