# Access Compliance Report

## Public Rights-of-Way

### (Curb Ramps)

Intersection ID: 22962	Main Street: DEER_TRAIL_LN	Cross Street: HUNTERS_LANDING_DR	Location: W
ADA ID: 8DD0DDF3D292	Ramp Type: Perpendicular	Initial Pass/Fail: Fail	Overall Compliance: No
Severity Score: 36.25			
Codes/Mitigation Info/Possible Solution		Field Measurements/Component Compliance

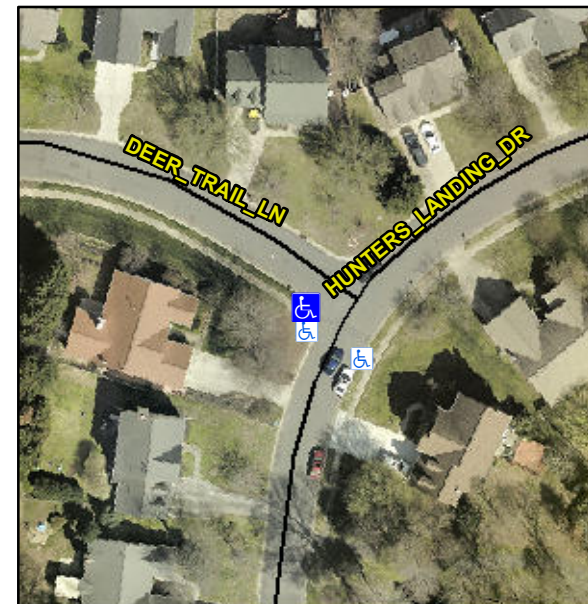
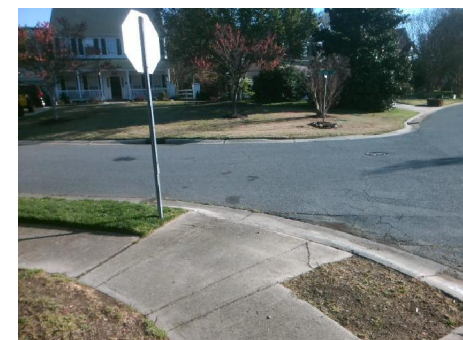
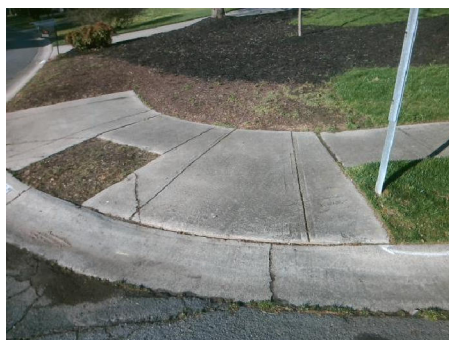
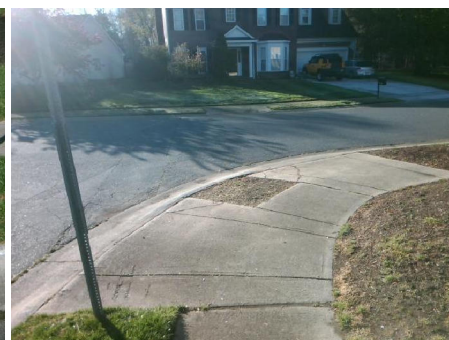
**R304.5.1, R304.5.3**

Compliance	Description	Data	Compliance	Description	Data
N/A	Ramp Length (in)	93.0	Yes	Ramp Slope (%)	5.3
No	Ramp Width (in)	31.0	No	Ramp XSlope (%)	3.3
N/A	Flare Type LT	N/A	N/A	Flare Type RT	N/A
N/A	Flare Slope LT (%)	N/A	N/A	Flare Slope RT (%)	N/A
N/A	Flare Traversable LT?	N/A	N/A	Flare Traversable RT?	N/A
N/A	Landing Length (in)	N/A	N/A	DWS Provided?	N/A
N/A	Landing Width (in)	N/A	N/A	DWS Contrast?	N/A
N/A	Landing Slope (%)	N/A	N/A	DWS Length (in)	N/A
N/A	Landing X Slope (%)	N/A	N/A	DWS Full Width?	N/A
N/A	Landing Curb? (Y/N)	N/A	N/A	DWS Offset (in)	N/A
N/A	Shared Landing?	N/A			
N/A	Gutter Ponding?	N/A	N/A	Gutter Slope (%)	N/A
N/A	Gutter Lip Ht (in)	N/A	N/A	Gutter X Slope (%)	N/A
N/A	Painted X Walk1?	No	N/A	Painted X Walk2?	N/A
	X Walk 1 Direction	To NE		X Walk 2 Direction	N/A
N/A	X Walk 1 Width (in)	N/A	N/A	X Walk 2 Width (in)	N/A
	X Walk 1 Slope (%)	4.9		X Walk 2 Slope (%)	N/A
	X Walk 1 X Slope (%)	1.0		X Walk 2 X Slope (%)	N/A

N/A	Ramp inside XWalk1?	N/A	N/A	Ramp inside XWalk2?	N/A
	Road Slope (%)	N/A	N/A	Clear Space?	N/A
	Road X Slope (%)	N/A	N/A	Clear Space to XWalk (in)	N/A
N/A	Any Obstructions?	N/A	N/A	Storm Grate/Utility Hazard?	N/A
	Obstruction Type			Storm Grate/Utility Type	
		N/A			N/A
			Yes	Surface Condition? (G/P)	Good

**Remove & Replace Entire Ramp.**
