# Access Compliance Report

## Public Rights-of-Way

### (Curb Ramps)

Intersection ID: 53746	Main Street: SPRINGWOOD_ESTATE_DR	Cross Street: CANTERBURY_CASTLE_DR	Location: NW
ADA ID: 8DDA74FE30F3	Ramp Type: Perp	Initial Pass/Fail: Fail	Overall Compliance: No
		Severity Score: 25

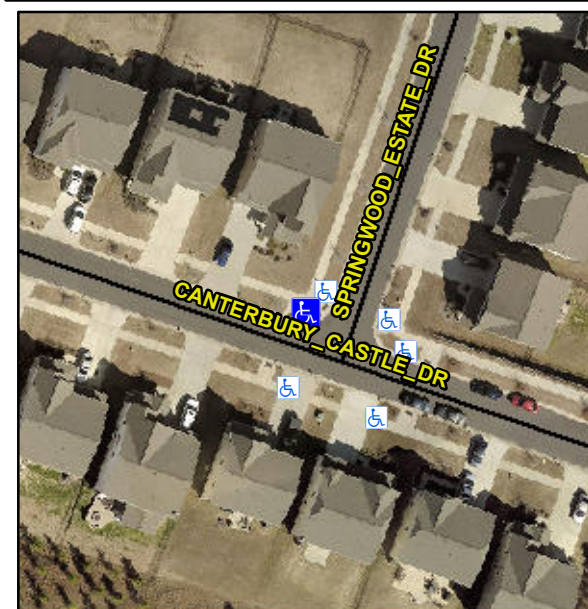
Compliance	Description	Data	Compliance	Description	Data
N/A	Ramp Length (in)	96.0	Yes	Ramp Slope (%)	6.2
Yes	Ramp Width (in)	48.0	No	Ramp XSlope (%)	8.1
N/A	Flare Type LT	N/A	N/A	Flare Type RT	N/A
N/A	Flare Slope LT (%)	N/A	N/A	Flare Slope RT (%)	N/A
N/A	Flare Traversable LT?	N/A	N/A	Flare Traversable RT?	N/A
N/A	Landing Length (in)	N/A	N/A	DWS Provided?	N/A
N/A	Landing Width (in)	N/A	N/A	DWS Contrast?	N/A
N/A	Landing Slope (%)	N/A	N/A	DWS Length (in)	N/A
N/A	Landing X Slope (%)	N/A	N/A	DWS Full Width?	N/A
N/A	Landing Curb? (Y/N)	N/A	N/A	DWS Offset (in)	N/A
N/A	Shared Landing?	N/A			
N/A	Gutter Ponding?	N/A	N/A	Gutter Slope (%)	N/A
N/A	Gutter Lip Ht (in)	N/A	N/A	Gutter X Slope (%)	N/A
N/A	Painted X Walk1?	No	N/A	Painted X Walk2?	N/A
	X Walk 1 Direction	To SW		X Walk 2 Direction	N/A
N/A	X Walk 1 Width (in)	N/A	N/A	X Walk 2 Width (in)	N/A
	X Walk 1 Slope (%)	3.6		X Walk 2 Slope (%)	N/A
	X Walk 1 X Slope (%)	4.3		X Walk 2 X Slope (%)	N/A

N/A	Ramp inside XWalk1?	N/A	N/A	Ramp inside XWalk2?	N/A
	Road Slope (%)	N/A	N/A	Clear Space?	N/A
	Road X Slope (%)	N/A	N/A	Clear Space to XWalk (in)	N/A
N/A	Any Obstructions?	N/A	N/A	Storm Grate/Utility Hazard?	N/A
	Obstruction Type			Storm Grate/Utility Type	
		N/A			N/A
			Yes	Surface Condition? (G/P)	Good

**Remove & Replace Entire Ramp.**

**R304.5.3**

**\$ 1850.00**
