Access Compliance Report Public Rights-of-Way (Curb Ramps)

Intersection ID: 10022282 Main Street: CAMBRIDGE_BELTWAY_DR Cross Street: N/A Location: S

ADA ID: 8DE45720D77A Ramp Type: Perpendicular Diagonal Initial Pass/Fail: Fail Overall Compliance: No Severity Score: 46.25

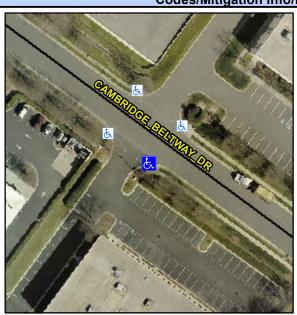
| Comp | liance Description | Data | Comp | liance Description | Data |
|---|---|---|---|---|---|
| N/A | Ramp Length (in) | 95.0 | No | Ramp Slope (%) | 9.1 |
| No | Ramp Width (in) | 42.5 | No | Ramp XSlope (%) | 7.1 |

Remove & Replace Curb Ramp With Two New Directional Ramps or Equivalent.

R304.5.1, R304.2.2, R304.5.3
