Intersection ID: 42552	Main Street: ESTHER_LN	Cross Street: LUNDY_LN	Location:	S
ADA ID: 8DF138D6AE54	Ramp Type: Perpendicular	Initial Pass/Fail: Fail	Overall Compliance: No	Severity Score: 8.75

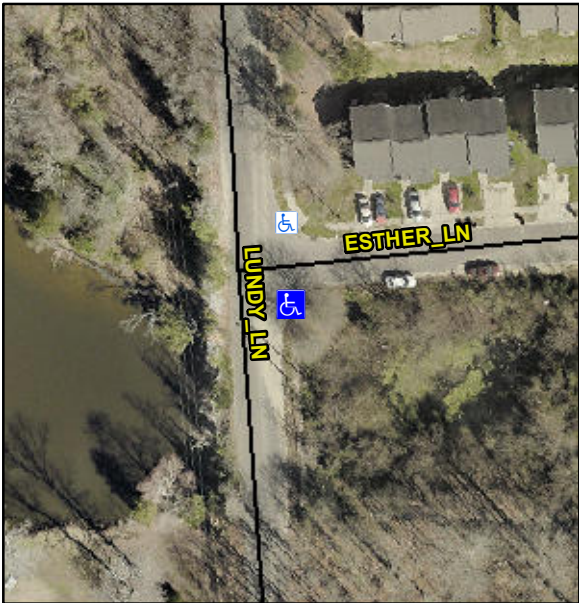
Compliance			Description			Data			Compliance			Description			Data		
N/A	Ramp Length (in)	49.0	Yes	Ramp Slope (%)	8.2	No	Ramp Width (in)	42.0	Yes	Ramp XSlope (%)	0.1	N/A	Flare Type LT	N/A	N/A	Flare Type RT	N/A
N/A	Flare Slope LT (%)	N/A	N/A	Flare Slope RT (%)	N/A	N/A	Flare Traversable LT?	N/A	N/A	Flare Traversable RT?	N/A	N/A	Landing Length (in)	N/A	N/A	DWS Provided?	N/A
N/A	Landing Width (in)	N/A	N/A	DWS Contrast?	N/A	N/A	Landing Slope (%)	N/A	N/A	DWS Length (in)	N/A	N/A	Landing X Slope (%)	N/A	N/A	DWS Full Width?	N/A
N/A	Landing Curb? (Y/N)	N/A	N/A	DWS Offset (in)	N/A	N/A	Shared Landing?	N/A				N/A	Gutter Ponding?	N/A	N/A	Gutter Slope (%)	N/A
N/A	Gutter Lip Ht (in)	N/A	N/A	Gutter X Slope (%)	N/A	N/A	Painted X Walk1?	No	N/A	Painted X Walk2?	N/A	N/A	Gutter X Slope (%)	N/A	N/A	Gutter X Slope (%)	N/A
N/A	X Walk 1 Direction	To N		X Walk 2 Direction	N/A	N/A	X Walk 1 Width (in)	N/A	N/A	X Walk 2 Width (in)	N/A	N/A	X Walk 1 Slope (%)	3.2		X Walk 2 Width (in)	N/A

N/A	X Walk 1 Slope (%)	0.9		X Walk 2 Slope (%)	N/A	N/A	X Walk 1 X Slope (%)	0.9		X Walk 2 X Slope (%)	N/A	N/A	X Walk 1 X Slope (%)	0.9		X Walk 2 X Slope (%)	N/A
N/A	Ramp inside XWalk1?	N/A	N/A	Ramp inside XWalk2?	N/A	N/A	Road Slope (%)	N/A	N/A	Clear Space?	N/A	N/A	Ramp inside XWalk1?	N/A	N/A	Clear Space?	N/A
N/A	Road X Slope (%)	N/A	N/A	Clear Space to XWalk (in)	N/A	N/A	Any Obstructions?	N/A	N/A	Storm Grate/Utility Hazard?	N/A	N/A	Road X Slope (%)	N/A	N/A	Clear Space to XWalk (in)	N/A
N/A	Obstruction Type		N/A	Storm Grate/Utility Type	N/A	N/A				Storm Grate/Utility Type	N/A	N/A	Obstruction Type			Storm Grate/Utility Type	N/A
			Yes	Surface Condition? (G/P)	Good

Possible Solutions:		Compliance			Compliance			
	<b>Remove &amp; Replace Entire Ramp.</b>		Description			Description			
			Data			Data			
			Compliance			Compliance			
			Description			Description			
			Data			Data			
			Compliance			Compliance			
			Description			Description			
			Data			Data			
			Compliance			Compliance			
Surveyor Notes:									
<b>N/A</b>									
PROW/ADA:									
<b>R304.5.1</b>									
Street 1 Name		<b>ESTHER LN</b>							
Stop Condition-Street 2		<b>StopSign</b>							
Street 2 Name		<b>N/A</b>							
Stop Condition-Street 1		<b>N/A</b>							
Total Cost:		<b>\$ 1850.00</b>
