Access Compliance Report

Public Rights-of-Way

(Curb Ramps)

Intersection ID: 47099	Main Street: GALLERIA_BV	Cross Street: N/A	Location: NW
ADA ID: 8DF330FDC940	Ramp Type: Perpendicular	Initial Pass/Fail: Fail	Overall Compliance: No
			Severity Score: 21.25

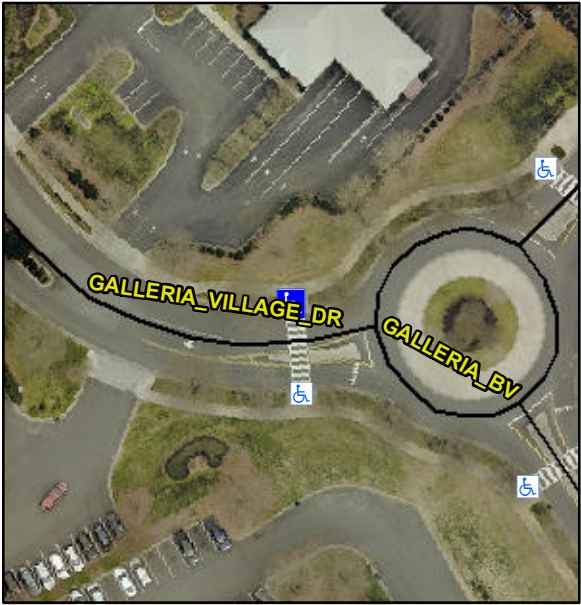
<p>Street 1 Name: GALLERIA BV</p> <p>Stop Condition-Street 2: YieldSign</p> <p>Street 2 Name: N/A</p> <p>Stop Condition-Street 1: N/A</p>	Possible Solutions:		Compliance	Description	Data
	Remove & Replace Entire Ramp.		N/A	Ramp Length (in)	94.0
			No	Ramp Width (in)	44.0
			N/A	Flare Type LT	N/A
			N/A	Flare Slope LT (%)	N/A
			N/A	Flare Traversable LT?	N/A
			N/A	Landing Length (in)	N/A
			N/A	Landing Width (in)	N/A
			N/A	Landing Slope (%)	N/A
			N/A	Landing X Slope (%)	N/A
			N/A	Landing Curb? (Y/N)	N/A
			N/A	Shared Landing?	N/A
			N/A	Gutter Ponding?	N/A
			N/A	Gutter Lip Ht (in)	N/A
			N/A	Painted X Walk1?	Yes
				X Walk 1 Direction	To SW
			N/A	X Walk 1 Width (in)	99.0
				X Walk 1 Slope (%)	0.9
				X Walk 1 X Slope (%)	0.5
			N/A	Ramp inside XWalk1?	Yes
<p>Surveyor Notes:</p> <p>N/A</p> <p>PROW/ADA:</p> <p>Not Found, R304.5.1, R304.2.2</p> <p>Total Cost: \$ 1850.00</p>			N/A	Flare Type RT	N/A

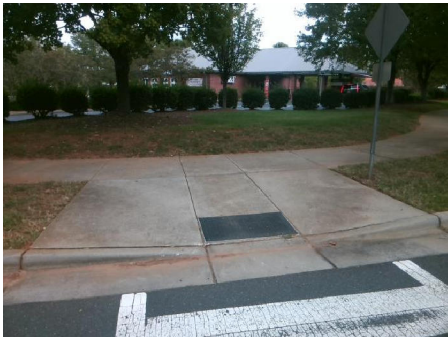
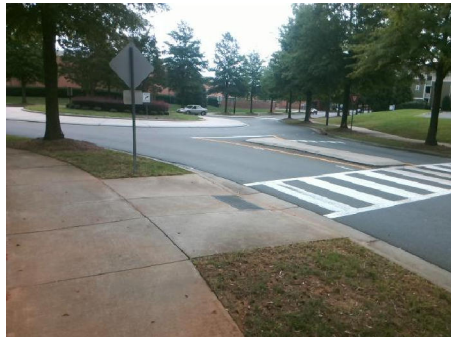
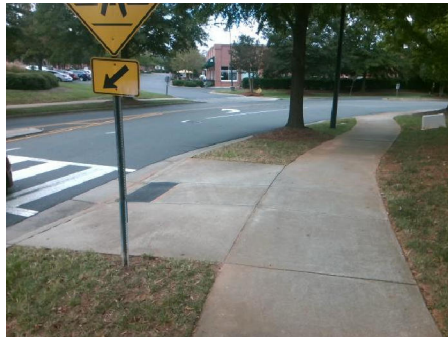
N/A	Flare Slope RT (%)	N/A
			N/A	Flare Traversable RT?	N/A
			N/A	DWS Provided?	N/A
			N/A	DWS Contrast?	N/A
			N/A	DWS Length (in)	N/A
			N/A	DWS Full Width?	N/A
			N/A	DWS Offset (in)	N/A
			N/A	Gutter Slope (%)	N/A
			N/A	Gutter X Slope (%)	N/A
			N/A	Painted X Walk2?	N/A
				X Walk 2 Direction	N/A
			N/A	X Walk 2 Width (in)	N/A
				X Walk 2 Slope (%)	N/A
				X Walk 2 X Slope (%)	N/A
			N/A	Ramp inside XWalk2?	N/A
			N/A	Clear Space?	N/A
			N/A	Clear Space to XWalk (in)	N/A
			N/A	Storm Grate/Utility Hazard?	N/A
				Storm Grate/Utility Type	
			N/A		N/A
			Yes	Surface Condition? (G/P)	Good
