Access Compliance Report

Public Rights-of-Way

(Curb Ramps)

Intersection ID: 18778	Main Street: E_INDEPENDENCE_BV	Cross Street: E_W_T_HARRIS_BV	Location: SW
ADA ID: 8E09F215D2E6	Ramp Type: Perpendicular	Initial Pass/Fail: Fail	Overall Compliance: No
Severity Score: 13.75			
Codes/Mitigation Info/Possible Solution		Field Measurements/Component Compliance

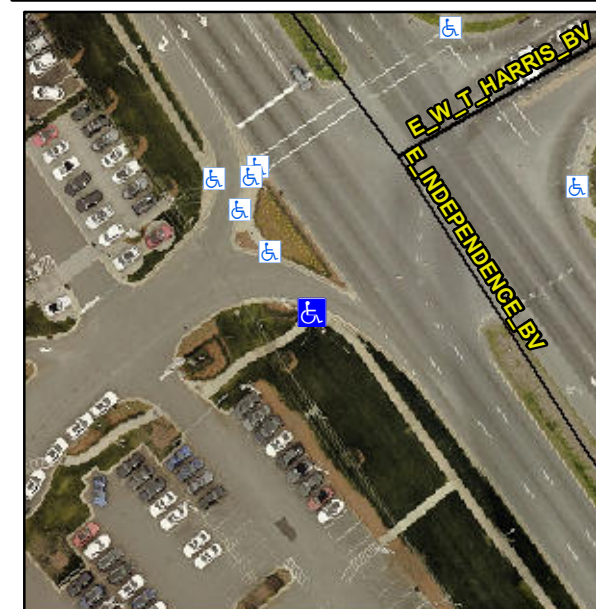
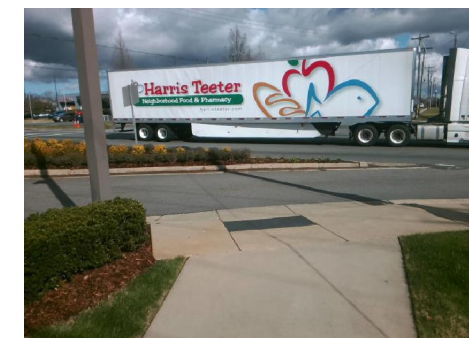
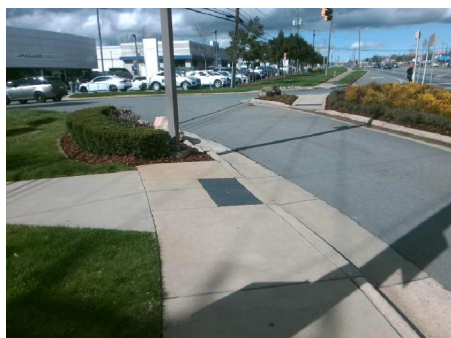
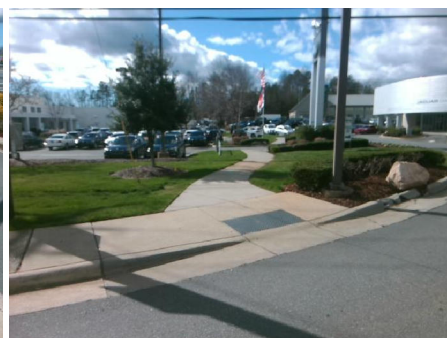
Not Found, R304.2.2, R304.5.3

Compliance	Description	Data	Compliance	Description	Data
N/A	Ramp Length (in)	57.0	No	Ramp Slope (%)	11.0
Yes	Ramp Width (in)	48.0	No	Ramp XSlope (%)	3.1
N/A	Flare Type LT	N/A	N/A	Flare Type RT	N/A
N/A	Flare Slope LT (%)	N/A	N/A	Flare Slope RT (%)	N/A
N/A	Flare Traversable LT?	N/A	N/A	Flare Traversable RT?	N/A
N/A	Landing Length (in)	N/A	N/A	DWS Provided?	N/A
N/A	Landing Width (in)	N/A	N/A	DWS Contrast?	N/A
N/A	Landing Slope (%)	N/A	N/A	DWS Length (in)	N/A
N/A	Landing X Slope (%)	N/A	N/A	DWS Full Width?	N/A
N/A	Landing Curb? (Y/N)	N/A	N/A	DWS Offset (in)	N/A
N/A	Shared Landing?	N/A			
N/A	Gutter Ponding?	N/A	N/A	Gutter Slope (%)	N/A
N/A	Gutter Lip Ht (in)	N/A	N/A	Gutter X Slope (%)	N/A
N/A	Painted X Walk1?	No	N/A	Painted X Walk2?	N/A
	X Walk 1 Direction	To NW		X Walk 2 Direction	N/A
N/A	X Walk 1 Width (in)	N/A	N/A	X Walk 2 Width (in)	N/A
	X Walk 1 Slope (%)	2.4		X Walk 2 Slope (%)	N/A
	X Walk 1 X Slope (%)	1.3		X Walk 2 X Slope (%)	N/A

N/A	Ramp inside XWalk1?	N/A	N/A	Ramp inside XWalk2?	N/A
	Road Slope (%)	N/A	N/A	Clear Space?	N/A
	Road X Slope (%)	N/A	N/A	Clear Space to XWalk (in)	N/A
N/A	Any Obstructions?	N/A	N/A	Storm Grate/Utility Hazard?	N/A
	Obstruction Type			Storm Grate/Utility Type	
		N/A			N/A
		Yes		Surface Condition? (G/P)	Good

Possible Solutions:

Remove & Replace Entire Ramp.
