# Access Compliance Report

## Public Rights-of-Way

### (Curb Ramps)

Intersection ID: 45096	Main Street: E_9TH_ST	Cross Street: N_DAVIDSON_ST	Location: NW
ADA ID: 8E0D6ED2DE0E	Ramp Type: Median Perpendicular	Initial Pass/Fail: Fail	Overall Compliance: No
			Severity Score: 13.75

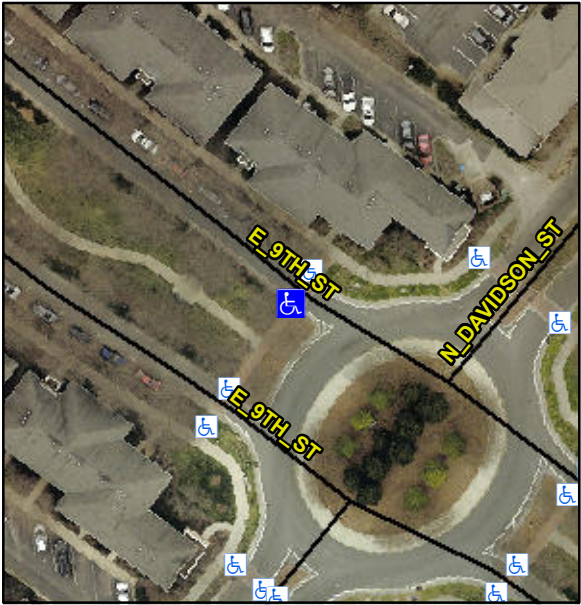
Possible Solutions:		<b>Compliance</b>	<b>Description</b>	<b>Data</b>
	<b>Remove &amp; Replace Entire Ramp.</b>		<b>No</b>	Ramp Length (in)	71.0
			<b>Yes</b>	Ramp Width (in)	74.0
			<b>N/A</b>	Flare Type LT	N/A
			<b>N/A</b>	Flare Slope LT (%)	N/A
			<b>N/A</b>	Flare Traversable LT?	N/A
			<b>N/A</b>	Landing Length (in)	N/A
			<b>N/A</b>	Landing Width (in)	N/A
			<b>N/A</b>	Landing Slope (%)	N/A
			<b>N/A</b>	Landing X Slope (%)	N/A
<p>Surveyor Notes:</p> <p><b>N/A</b></p> <p>PROW/ADA:</p> <p><b>Not Found, R304.2.2, R304.5.3</b></p>			<b>N/A</b>	Flare Type RT	N/A
			<b>N/A</b>	Flare Slope RT (%)	N/A
			<b>N/A</b>	Flare Traversable RT?	N/A
			<b>N/A</b>	DWS Provided?	N/A
			<b>N/A</b>	DWS Contrast?	N/A
			<b>N/A</b>	DWS Length (in)	N/A
			<b>N/A</b>	DWS Full Width?	N/A
			<b>N/A</b>	DWS Offset (in)	N/A
			<b>N/A</b>	Gutter Ponding?	N/A

<b>N/A</b>	Gutter Lip Ht (in)	N/A
			<b>Yes</b>	Painted X Walk1?	N/A
			<b>To N</b>	X Walk 1 Direction	N/A
			<b>N/A</b>	X Walk 1 Width (in)	82.0
			<b>2.9</b>	X Walk 1 Slope (%)	N/A
			<b>3.9</b>	X Walk 1 X Slope (%)	N/A
			<b>N/A</b>	Ramp inside XWalk1?	N/A
			<b>N/A</b>	Road Slope (%)	N/A
			<b>N/A</b>	Road X Slope (%)	N/A
			<b>N/A</b>	Any Obstructions?	N/A
				Obstruction Type	N/A
Total Cost:			<b>\$</b>	<b>1650.00</b>	
			<b>N/A</b>		<b>N/A</b>
			<b>Yes</b>	Surface Condition? (G/P)	<b>Good</b>
