## Access Compliance Report Public Rights-of-Way (Curb Ramps)

Intersection ID: 15195Main Street: ALBEMARLE\_RDCross Street: FARM\_POND\_LNLocation: NWADA ID: 8E12F4CD1624Ramp Type: PerpendicularInitial Pass/Fail: Fail Overall Compliance: NoSeverity Score: 21.25

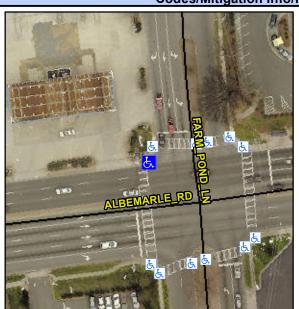
Field Measurements/Component Compliance						
Comp	liance Description	Data	Comp	liance Description	Data	
N/A	Ramp Length (in)	51.0	No	Ramp Slope (%)	10.9	
No	Ramp Width (in)	46.0	Yes	Ramp XSlope (%)	2.0	
N/A	Flare Type LT	N/A	N/A	Flare Type RT	N/A	
N/A	Flare Slope LT (%)	N/A	N/A	Flare Slope RT (%)	N/A	
N/A	Flare Traversable LT?	N/A	N/A	Flare Traversable RT?	N/A	
N/A	Landing Length (in)	N/A	N/A	DWS Provided?	N/A	
N/A	Landing Width (in)	N/A	N/A	DWS Contrast?	N/A	
N/A	Landing Slope (%)	N/A	N/A	DWS Length (in)	N/A	
N/A	Landing X Slope (%)	N/A	N/A	DWS Full Width?	N/A	
N/A	Landing Curb? (Y/N)	N/A	N/A	DWS Offset (in)	N/A	
N/A	Shared Landing?	N/A				
N/A	Gutter Ponding?	N/A	N/A	Gutter Slope (%)	N/A	
N/A	Gutter Lip Ht (in)	N/A	N/A	Gutter X Slope (%)	N/A	
N/A	Painted X Walk1?	No	N/A	Painted X Walk2?	N/A	
	X Walk 1 Direction	To S		X Walk 2 Direction	N/A	
N/A	X Walk 1 Width (in)	N/A	N/A	X Walk 2 Width (in)	N/A	
	X Walk 1 Slope (%)	2.0		X Walk 2 Slope (%)	N/A

X Walk 1 X Slope (%)	3.1		X Walk 2 X Slope (%)	N/A	
N/A	Ramp inside XWalk1?	N/A	N/A	Ramp inside XWalk2?	N/A	
	Road Slope (%)	N/A	N/A	Clear Space?	N/A	
	Road X Slope (%)	N/A	N/A	Clear Space to XWalk (in)	N/A	
N/A	Any Obstructions?	N/A	N/A	Storm Grate/Utility Hazard?	N/A	
	Obstruction Type			Storm Grate/Utility Type		
		N/A			N/A	
			Yes	Surface Condition? (G/P)	Good

Possible Solutions:	9	
Remove & Replace Entire Ramp.		
·	N	
	N	
	1	
	1	
	1	
Surveyor Notes:	1	
N/A	N	
	1	
	1	
	1	
PROW/ADA:	1	
Not Found, R304.5.1, R304.2.2	N	
	1	
	N	
	١
