Access Compliance Report

Public Rights-of-Way

(Curb Ramps)

Intersection ID: 9490	Main Street: BARRINGTON_DR	Cross Street: CRAFTSBURY_DR	Location:	W
ADA ID: 8E13638E9798	Ramp Type: Perpendicular	Initial Pass/Fail: Fail	Overall Compliance: No	Severity Score: 1.25
Codes/Mitigation Info/Possible Solution		Field Measurements/Component Compliance

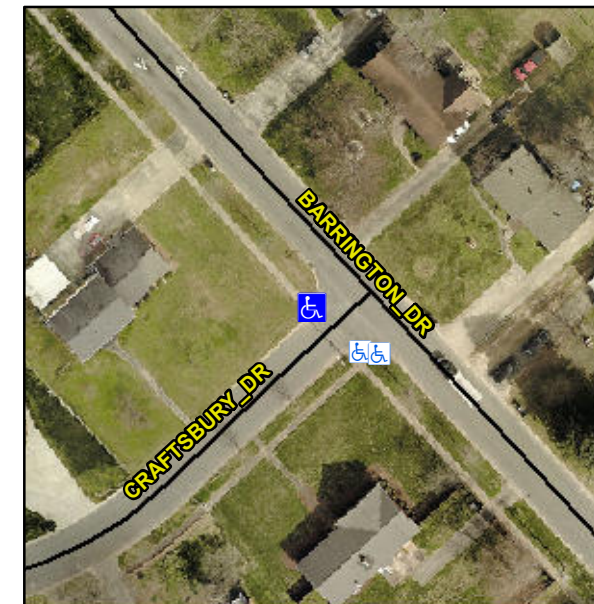
Not Found, R304.5.3

Compliance	Description	Data	Compliance	Description	Data
N/A	Ramp Length (in)	69.0	Yes	Ramp Slope (%)	5.5
Yes	Ramp Width (in)	48.0	No	Ramp XSlope (%)	2.3
N/A	Flare Type LT	N/A	N/A	Flare Type RT	N/A
N/A	Flare Slope LT (%)	N/A	N/A	Flare Slope RT (%)	N/A
N/A	Flare Traversable LT?	N/A	N/A	Flare Traversable RT?	N/A
N/A	Landing Length (in)	N/A	N/A	DWS Provided?	N/A
N/A	Landing Width (in)	N/A	N/A	DWS Contrast?	N/A
N/A	Landing Slope (%)	N/A	N/A	DWS Length (in)	N/A
N/A	Landing X Slope (%)	N/A	N/A	DWS Full Width?	N/A
N/A	Landing Curb? (Y/N)	N/A	N/A	DWS Offset (in)	N/A
N/A	Shared Landing?	N/A			
N/A	Gutter Ponding?	Yes	N/A	Gutter Slope (%)	N/A
N/A	Gutter Lip Ht (in)	0.5	N/A	Gutter X Slope (%)	N/A
N/A	Painted X Walk1?	No	N/A	Painted X Walk2?	N/A
	X Walk 1 Direction	To SE		X Walk 2 Direction	N/A
N/A	X Walk 1 Width (in)	N/A	N/A	X Walk 2 Width (in)	N/A
	X Walk 1 Slope (%)	4.1		X Walk 2 Slope (%)	N/A
	X Walk 1 X Slope (%)	0.1		X Walk 2 X Slope (%)	N/A

N/A	Ramp inside XWalk1?	N/A	N/A	Ramp inside XWalk2?	N/A
	Road Slope (%)	N/A	N/A	Clear Space?	N/A
	Road X Slope (%)	N/A	N/A	Clear Space to XWalk (in)	N/A
N/A	Any Obstructions?	N/A	N/A	Storm Grate/Utility Hazard?	N/A
	Obstruction Type			Storm Grate/Utility Type	
		N/A			N/A
		Yes		Surface Condition? (G/P)	Good

Possible Solutions:

Remove & Replace Entire Ramp.

Total Cost:

\$ 1850.00
