Access Compliance Report

Public Rights-of-Way (Curb Ramps)

Intersection ID: 42729	Main Street: CALDWELL_FOREST_DR	Cross Street: COCHRAN_RIDGE_AV	Location:	E
ADA ID: 8E136CB7BCCF	Ramp Type: Perpendicular	Initial Pass/Fail: Fail	Overall Compliance: No	Severity Score: 10
Codes/Mitigation Info/Possible Solution		Field Measurements/Component Compliance

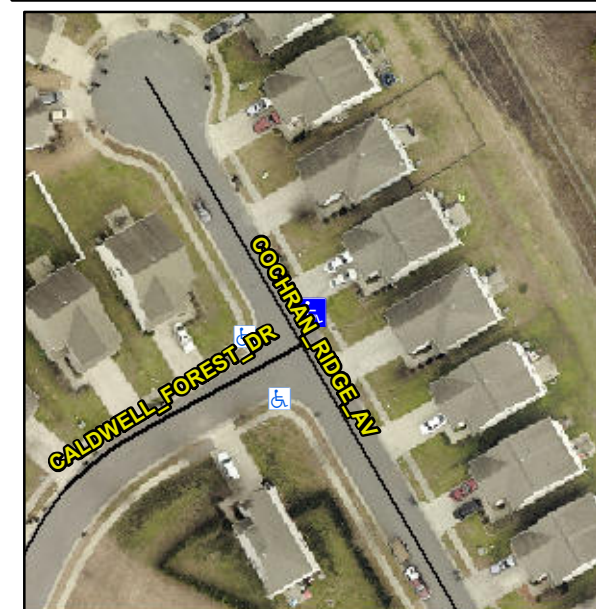
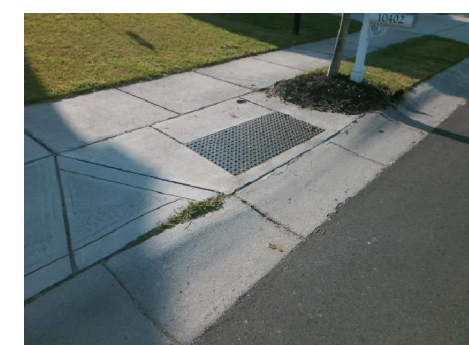
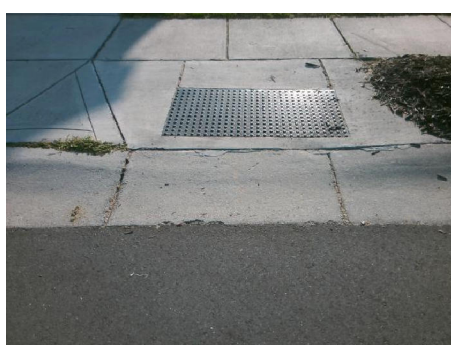
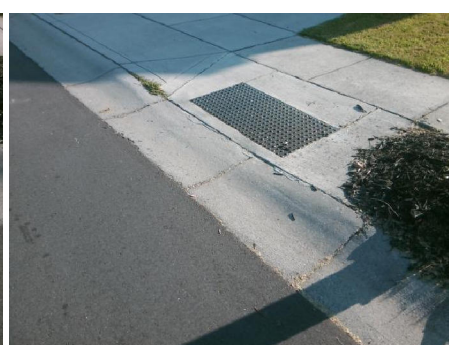
Compliance	Description	Data	Compliance	Description	Data
N/A	Ramp Length (in)	46.0	Yes	Ramp Slope (%)	6.7
No	Ramp Width (in)	45.5	Yes	Ramp XSlope (%)	2.1
N/A	Flare Type LT	N/A	N/A	Flare Type RT	N/A
N/A	Flare Slope LT (%)	N/A	N/A	Flare Slope RT (%)	N/A
N/A	Flare Traversable LT?	N/A	N/A	Flare Traversable RT?	N/A
N/A	Landing Length (in)	N/A	N/A	DWS Provided?	N/A
N/A	Landing Width (in)	N/A	N/A	DWS Contrast?	N/A
N/A	Landing Slope (%)	N/A	N/A	DWS Length (in)	N/A
N/A	Landing X Slope (%)	N/A	N/A	DWS Full Width?	N/A
N/A	Landing Curb? (Y/N)	N/A	N/A	DWS Offset (in)	N/A
N/A	Shared Landing?	N/A			
N/A	Gutter Ponding?	N/A	N/A	Gutter Slope (%)	N/A
N/A	Gutter Lip Ht (in)	N/A	N/A	Gutter X Slope (%)	N/A
N/A	Painted X Walk1?	No	N/A	Painted X Walk2?	N/A
	X Walk 1 Direction	To W		X Walk 2 Direction	N/A
N/A	X Walk 1 Width (in)	N/A	N/A	X Walk 2 Width (in)	N/A
	X Walk 1 Slope (%)	3.5		X Walk 2 Slope (%)	N/A
	X Walk 1 X Slope (%)	2.3		X Walk 2 X Slope (%)	N/A

N/A	Ramp inside XWalk1?	N/A	N/A	Ramp inside XWalk2?	N/A
	Road Slope (%)	N/A	N/A	Clear Space?	N/A
	Road X Slope (%)	N/A	N/A	Clear Space to XWalk (in)	N/A
N/A	Any Obstructions?	N/A	N/A	Storm Grate/Utility Hazard?	N/A
	Obstruction Type			Storm Grate/Utility Type	
		N/A			N/A
			Yes	Surface Condition? (G/P)	Good

Possible Solutions:

Remove & Replace Entire Ramp.

R304.5.1

\$ 1850.00
