Access Compliance Report Public Rights-of-Way (Curb Ramps)

Intersection ID: 11401 Main Street: GRACE ST Cross Street: HARRILL_ST Location: SE

Ramp Type: Perpendicular **Overall Compliance: No** Severity Score: 33.75 **ADA ID: 8E137DEB7DE6** Initial Pass/Fail: Fail

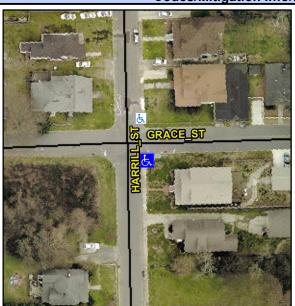
Field Measurements/Component Compliance								
Comp	Compliance Description		Compliance Description		Data			
N/A	Ramp Length (in)	58.0	No	Ramp Slope (%)	13.0			
No	Ramp Width (in)	39.0	Yes	Ramp XSlope (%)	0.2			
N/A	Flare Type LT	N/A	N/A	Flare Type RT	N/A			
N/A	Flare Slope LT (%)	N/A	N/A	Flare Slope RT (%)	N/A			
N/A	Flare Traversable LT?	N/A	N/A	Flare Traversable RT?	N/A			
N/A	Landing Length (in)	N/A	N/A	DWS Provided?	N/A			
N/A	Landing Width (in)	N/A	N/A	DWS Contrast?	N/A			
N/A	Landing Slope (%)	N/A	N/A	DWS Length (in)	N/A			
N/A	Landing X Slope (%)	N/A	N/A	DWS Full Width?	N/A			
N/A	Landing Curb? (Y/N)	N/A	N/A	DWS Offset (in)	N/A			
N/A	Shared Landing?	N/A						
N/A	Gutter Ponding?	Yes	N/A	Gutter Slope (%)	N/A			
N/A	Gutter Lip Ht (in)	N/A	N/A	Gutter X Slope (%)	N/A			
N/A	Painted X Walk1?	No	N/A	Painted X Walk2?	N/A			
	X Walk 1 Direction	To N		X Walk 2 Direction	N/A			
N/A	X Walk 1 Width (in)	N/A	N/A	X Walk 2 Width (in)	N/A

X Walk 1 Slope (%)	0.6		X Walk 2 Slope (%)	N/A			
	X Walk 1 X Slope (%)	2.2		X Walk 2 X Slope (%)	N/A			
N/A	Ramp inside XWalk1?	N/A	N/A	Ramp inside XWalk2?	N/A			
	Road Slope (%)	N/A	N/A	Clear Space?	N/A			
	Road X Slope (%)	N/A	N/A	Clear Space to XWalk (in)	N/A			
N/A	Any Obstructions?	N/A	N/A	Storm Grate/Utility Hazard?	N/A			
	Obstruction Type			Storm Grate/Utility Type				
		N/A			N/A			
			Yes	Surface Condition? (G/P)	Good

1	Possible Solutions:	•
	Remove & Replace Entire Ramp.	
Š		
-		
	Surveyor Natoo	
	Surveyor Notes:	
10	N/A	
-	PROW/ADA:	
	Not Found, R304.5.1, R304.2.2	I
la S	,,
