# Access Compliance Report

## Public Rights-of-Way

### (Curb Ramps)

Intersection ID: 4480	Main Street: KEMPSFORD_DR	Cross Street: SILVER_GLEN_LN	Location: SE
ADA ID: 8E1710371C40	Ramp Type: Perpendicular Diagonal	Initial Pass/Fail: Fail	Overall Compliance: No
		Severity Score: 8.75

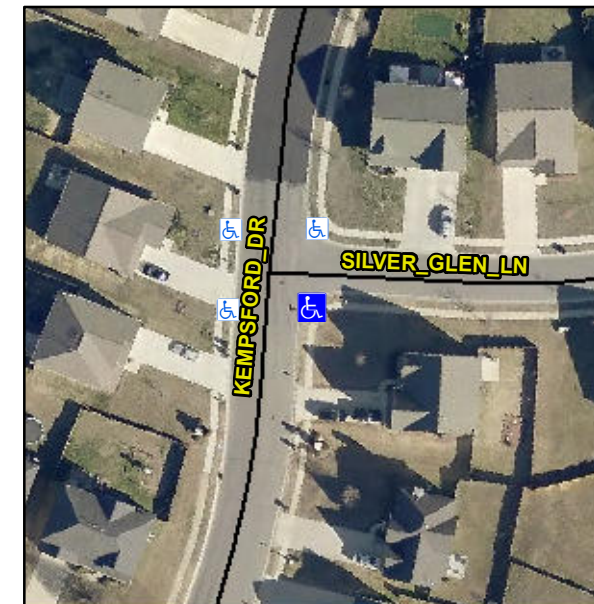
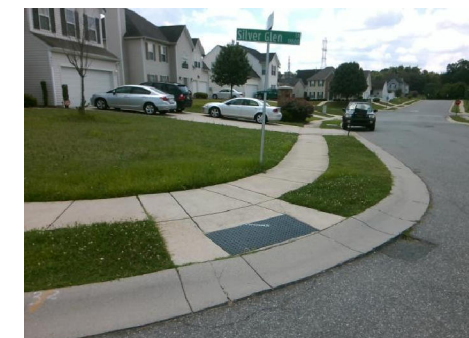
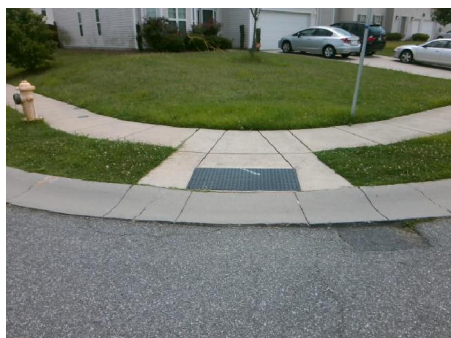
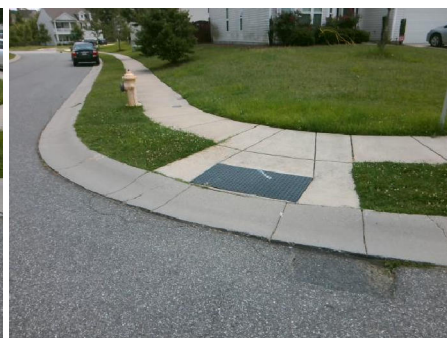
**Not Found, R304.5.1**

Compliance	Description	Data	Compliance	Description	Data
N/A	Ramp Length (in)	48.0	Yes	Ramp Slope (%)	5.0
No	Ramp Width (in)	39.0	Yes	Ramp XSlope (%)	1.0
N/A	Flare Type LT	N/A	N/A	Flare Type RT	N/A
N/A	Flare Slope LT (%)	N/A	N/A	Flare Slope RT (%)	N/A
N/A	Flare Traversable LT?	N/A	N/A	Flare Traversable RT?	N/A
N/A	Landing Length (in)	N/A	N/A	DWS Provided?	N/A
N/A	Landing Width (in)	N/A	N/A	DWS Contrast?	N/A
N/A	Landing Slope (%)	N/A	N/A	DWS Length (in)	N/A
N/A	Landing X Slope (%)	N/A	N/A	DWS Full Width?	N/A
N/A	Landing Curb? (Y/N)	N/A	N/A	DWS Offset (in)	N/A
N/A	Shared Landing?	N/A			
N/A	Gutter Ponding?	N/A	N/A	Gutter Slope (%)	N/A
N/A	Gutter Lip Ht (in)	1.0	N/A	Gutter X Slope (%)	N/A
N/A	Painted X Walk1?	No	N/A	Painted X Walk2?	No
	X Walk 1 Direction	To N		X Walk 2 Direction	To W
N/A	X Walk 1 Width (in)	N/A	N/A	X Walk 2 Width (in)	N/A
	X Walk 1 Slope (%)	1.3		X Walk 2 Slope (%)	2.9
	X Walk 1 X Slope (%)	2.5		X Walk 2 X Slope (%)	1.8

N/A	Ramp inside XWalk1?	N/A	N/A	Ramp inside XWalk2?	N/A
	Road Slope (%)	0.4	N/A	Clear Space?	N/A
	Road X Slope (%)	1.3	N/A	Clear Space to XWalk (in)	N/A
N/A	Any Obstructions?	N/A	N/A	Storm Grate/Utility Hazard?	N/A
	Obstruction Type			Storm Grate/Utility Type	
		N/A			N/A
			Yes	Surface Condition? (G/P)	Good

**Remove & Replace Curb Ramp With Two New Directional Ramps or Equivalent.**

Total Cost: \$ 3200.00
