Access Compliance Report

Public Rights-of-Way

(Curb Ramps)

Intersection ID: 13859	Main Street: CLEVELAND_AV	Cross Street: RENSSELAER_AV	Location: W
ADA ID: 8E2E08CEA8DD	Ramp Type: PerpDiag	Initial Pass/Fail: Fail	Overall Compliance: No
Severity Score: 50			
Codes/Mitigation Info/Possible Solution		Field Measurements/Component Compliance

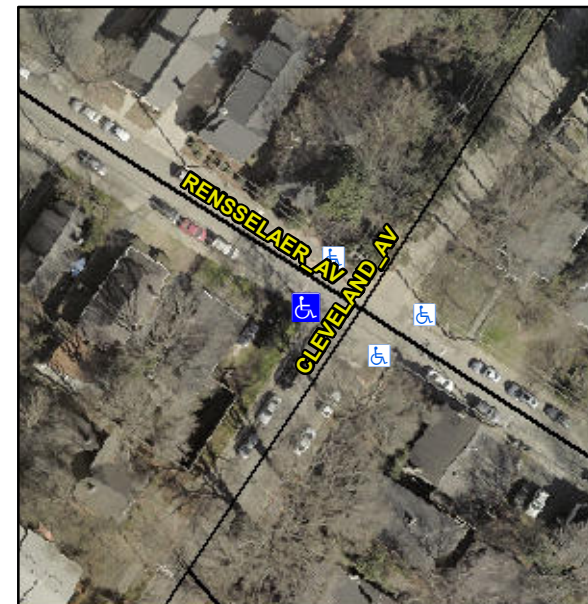
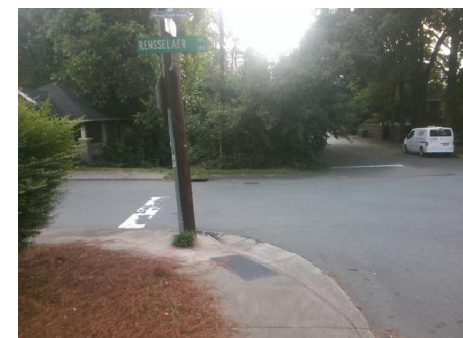
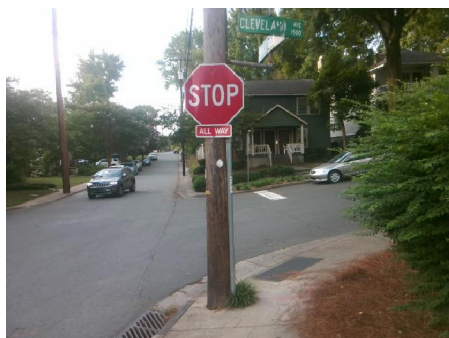
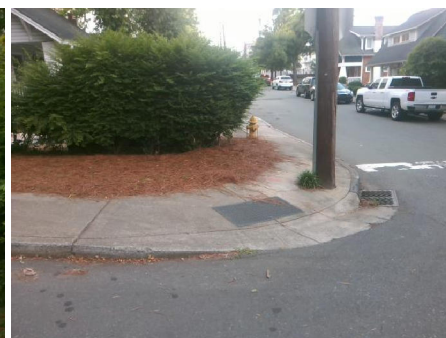
Not Found, R304.2.2, R304.5.3

Compliance	Description	Data	Compliance	Description	Data
N/A	Ramp Length (in)	60.0	No	Ramp Slope (%)	14.1
Yes	Ramp Width (in)	48.0	No	Ramp XSlope (%)	9.5
N/A	Flare Type LT	N/A	N/A	Flare Type RT	N/A
N/A	Flare Slope LT (%)	N/A	N/A	Flare Slope RT (%)	N/A
N/A	Flare Traversable LT?	N/A	N/A	Flare Traversable RT?	N/A
N/A	Landing Length (in)	N/A	N/A	DWS Provided?	N/A
N/A	Landing Width (in)	N/A	N/A	DWS Contrast?	N/A
N/A	Landing Slope (%)	N/A	N/A	DWS Length (in)	N/A
N/A	Landing X Slope (%)	N/A	N/A	DWS Full Width?	N/A
N/A	Landing Curb? (Y/N)	N/A	N/A	DWS Offset (in)	N/A
N/A	Shared Landing?	N/A			
N/A	Gutter Ponding?	N/A	N/A	Gutter Slope (%)	N/A
N/A	Gutter Lip Ht (in)	N/A	N/A	Gutter X Slope (%)	N/A
N/A	Painted X Walk1?	No	N/A	Painted X Walk2?	No
	X Walk 1 Direction	To SE		X Walk 2 Direction	To NE
N/A	X Walk 1 Width (in)	N/A	N/A	X Walk 2 Width (in)	N/A
	X Walk 1 Slope (%)	1.7		X Walk 2 Slope (%)	1.2
	X Walk 1 X Slope (%)	7.1		X Walk 2 X Slope (%)	0.1

N/A	Ramp inside XWalk1?	N/A	N/A	Ramp inside XWalk2?	N/A
	Road Slope (%)	8.1	N/A	Clear Space?	N/A
	Road X Slope (%)	2.7	N/A	Clear Space to XWalk (in)	N/A
N/A	Any Obstructions?	N/A	N/A	Storm Grate/Utility Hazard?	N/A
	Obstruction Type			Storm Grate/Utility Type	
		N/A			N/A
			Yes	Surface Condition? (G/P)	Good

Possible Solutions:

Remove & Replace Curb Ramp With Two New Directional Ramps or Equivalent.
