Access Compliance Report

Public Rights-of-Way

(Curb Ramps)

Intersection ID: 3596	Main Street: DARBYSHIRE_PL	Cross Street: TREYBURN_DR	Location: W
ADA ID: 8E2EB8FA9DA4	Ramp Type: Perpendicular	Initial Pass/Fail: Fail	Overall Compliance: No
Codes/Mitigation Info/Possible Solution			Severity Score: 12.5
			Field Measurements/Component Compliance

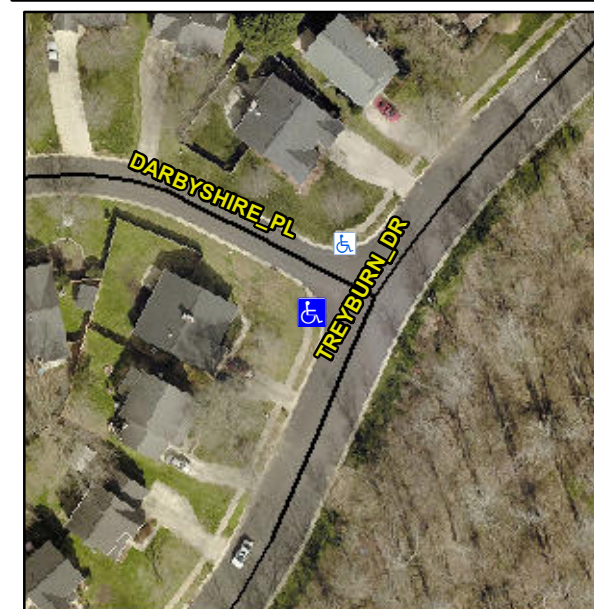
Not Found, R304.2.2

Compliance	Description	Data	Compliance	Description	Data
N/A	Ramp Length (in)	47.0	No	Ramp Slope (%)	8.5
Yes	Ramp Width (in)	48.0	Yes	Ramp XSlope (%)	1.8
N/A	Flare Type LT	N/A	N/A	Flare Type RT	N/A
N/A	Flare Slope LT (%)	N/A	N/A	Flare Slope RT (%)	N/A
N/A	Flare Traversable LT?	N/A	N/A	Flare Traversable RT?	N/A
N/A	Landing Length (in)	N/A	N/A	DWS Provided?	N/A
N/A	Landing Width (in)	N/A	N/A	DWS Contrast?	N/A
N/A	Landing Slope (%)	N/A	N/A	DWS Length (in)	N/A
N/A	Landing X Slope (%)	N/A	N/A	DWS Full Width?	N/A
N/A	Landing Curb? (Y/N)	N/A	N/A	DWS Offset (in)	N/A
N/A	Shared Landing?	N/A			
N/A	Gutter Ponding?	N/A	N/A	Gutter Slope (%)	N/A
N/A	Gutter Lip Ht (in)	N/A	N/A	Gutter X Slope (%)	N/A
N/A	Painted X Walk1?	No	N/A	Painted X Walk2?	N/A
	X Walk 1 Direction	To NE		X Walk 2 Direction	N/A
N/A	X Walk 1 Width (in)	N/A	N/A	X Walk 2 Width (in)	N/A
	X Walk 1 Slope (%)	0.6		X Walk 2 Slope (%)	N/A
	X Walk 1 X Slope (%)	1.3		X Walk 2 X Slope (%)	N/A

N/A	Ramp inside XWalk1?	N/A	N/A	Ramp inside XWalk2?	N/A
	Road Slope (%)	N/A	N/A	Clear Space?	N/A
	Road X Slope (%)	N/A	N/A	Clear Space to XWalk (in)	N/A
N/A	Any Obstructions?	N/A	N/A	Storm Grate/Utility Hazard?	N/A
	Obstruction Type			Storm Grate/Utility Type	
		N/A			N/A
			Yes	Surface Condition? (G/P)	Good

Possible Solutions:

Remove & Replace Entire Ramp.
