Access Compliance Report Public Rights-of-Way (Curb Ramps)

Intersection ID: 50232 Main Street: MARVIN_RD Cross Street: LONGSTONE_LN Location: W

ADA ID: 8E30B2F65710 Ramp Type: Perpendicular Diagonal Initial Pass/Fail: Pass Overall Compliance: No Severity Score: 0.25

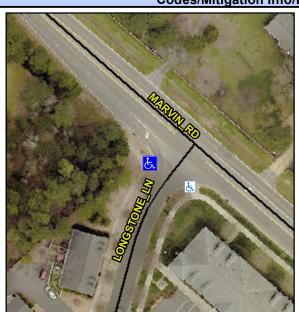
Not Found, R304.5.3, R305.2

Field Measurements/Component Compilance					
Compliance Description		Data	Compliance Description		Data
N/A	Ramp Length (in)	83.0	Yes	Ramp Slope (%)	7.2
Yes	Ramp Width (in)	48.0	No	Ramp XSlope (%)	2.8
N/A	Flare Type LT	Sloped	N/A	Flare Type RT	N/A
N/A	Flare Slope LT (%)	10.0	Yes	Flare Slope RT (%)	0.9
N/A	Flare Traversable LT?	Yes	N/A	Flare Traversable RT?	Yes
Yes	Landing Length (in)	72.0	Yes	DWS Provided?	Yes
Yes	Landing Width (in)	48.0	Yes	DWS Contrast?	Yes
Yes	Landing Slope (%)	1.4	Yes	DWS Length (in)	24.0
No	Landing X Slope (%)	5.8	Yes	DWS Full Width?	Yes
N/A	Landing Curb? (Y/N)	No	No	DWS Offset (in)	3.5
N/A	Shared Landing?	No			
Yes	Gutter Ponding?	No	Yes	Gutter Slope (%)	3.0
Yes	Gutter Lip Ht (in)	0.0	Yes	Gutter X Slope (%)	1.5
N/A	Painted X Walk1?	No	N/A	Painted X Walk2?	No
	X Walk 1 Direction	To SE		X Walk 2 Direction	To NE
N/A	X Walk 1 Width (in)	N/A	N/A	X Walk 2 Width (in)	N/A
	X Walk 1 Slope (%)	0.4		X Walk 2 Slope (%)	2.3

X Walk 1 X Slope (%)	2.4		X Walk 2 X Slope (%)	0.0
N/A	Ramp inside XWalk1?	N/A	N/A	Ramp inside XWalk2?	N/A
	Road Slope (%)	2.6	N/A	Clear Space?	Yes
	Road X Slope (%)	3.2	N/A	Clear Space to XWalk (in)	N/A
Yes	Any Obstructions?	No	Yes	Storm Grate/Utility Hazard?	No
	Obstruction Type			Storm Grate/Utility Type	
		N/A			N/A
			Yes	Surface Condition? (G/P)	Good

LONGSTONE LN StopSign MARVIN RD None Possible Solutions:

Remove & Replace Curb Ramp With Two New Directional Ramps or Equivalent.

Total Cost: \$ 3200.00
