Access Compliance Report Public Rights-of-Way (Curb Ramps)

Intersection ID: 15373 Main Street: WINFIELD_DR Cross Street: PIERSON_DR Location: W

ADA ID: 8E3378D42E34 Ramp Type: Perpendicular Initial Pass/Fail: Pass Overall Compliance: No Severity Score: 12.5

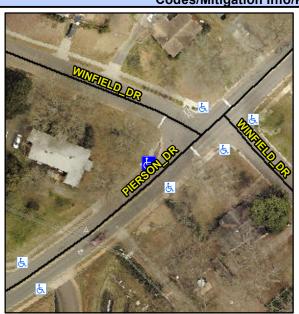
| 000.0.0 00.00.0 | | | | | |
|---|--|--|--|--|--|
| Not Found, R304.2.1, R304.2.2-Perp, R304.3.2-Para, R304.5.3, R305.1.4, R305.2 | | | | | |

| Field Measurements/Component Compliance | | | | | | |
|---|---|---|---|---|---|--|
| N/A | Ramp Length (in) | 88.0 | Yes | Ramp Slope (%) | 6.8 | |
| No | Landing Length (in) | N/A | Yes | DWS Provided? | Yes | |
| No | Landing Width (in) | N/A | Yes | DWS Contrast? | Yes | |
| No | Landing Slope (%) | N/A | Yes | DWS Length (in) | 25.5 | |
| No | Landing X Slope (%) | N/A | No | DWS Full Width? | No | |
| N/A | Landing Curb? (Y/N) | No | No | DWS Offset (in) | 3.5 | |
| Yes | Gutter Lip Ht (in) | 0.0 | No | Gutter X Slope (%) | 3.0 | |

| 000.0.0 00.00.0 | | | | | |
|---|--|--|--|--|--|
| Remove & Replace Entire Ramp. Remove & Replace Gutter. | | | | | |
