# Access Compliance Report

## Public Rights-of-Way

### (Curb Ramps)

Intersection ID: 18089	Main Street: HARRIS_RD	Cross Street: SHARON_RD	Location:	N
ADA ID: 8E40A18C8E1E	Ramp Type: Perpendicular Diagonal	Initial Pass/Fail: Fail	Overall Compliance: No	Severity Score: 21.25

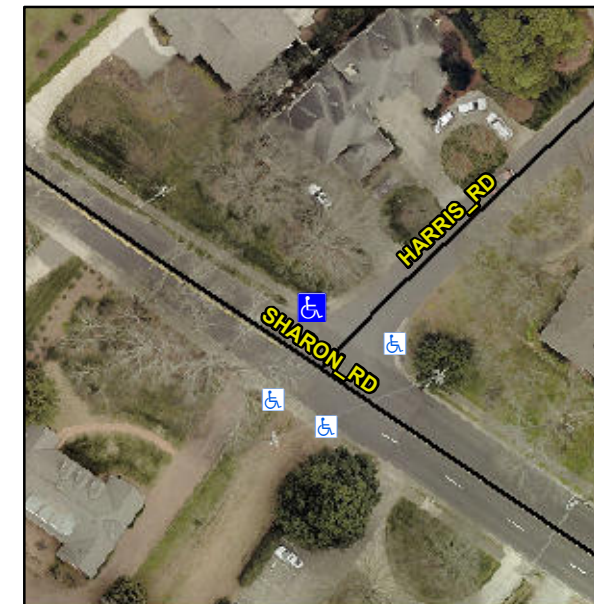
**Not Found, R304.5.1, R304.2.2**

Compliance	Description	Data	Compliance	Description	Data
N/A	Ramp Length (in)	57.0	No	Ramp Slope (%)	11.8
No	Ramp Width (in)	42.0	Yes	Ramp XSlope (%)	1.4
N/A	Flare Type LT	N/A	N/A	Flare Type RT	N/A
N/A	Flare Slope LT (%)	N/A	N/A	Flare Slope RT (%)	N/A
N/A	Flare Traversable LT?	N/A	N/A	Flare Traversable RT?	N/A
N/A	Landing Length (in)	N/A	N/A	DWS Provided?	N/A
N/A	Landing Width (in)	N/A	N/A	DWS Contrast?	N/A
N/A	Landing Slope (%)	N/A	N/A	DWS Length (in)	N/A
N/A	Landing X Slope (%)	N/A	N/A	DWS Full Width?	N/A
N/A	Landing Curb? (Y/N)	N/A	N/A	DWS Offset (in)	N/A
N/A	Shared Landing?	N/A			
N/A	Gutter Ponding?	N/A	N/A	Gutter Slope (%)	N/A
N/A	Gutter Lip Ht (in)	N/A	N/A	Gutter X Slope (%)	N/A
N/A	Painted X Walk1?	No	N/A	Painted X Walk2?	No
	X Walk 1 Direction	To SW		X Walk 2 Direction	To SE
N/A	X Walk 1 Width (in)	N/A	N/A	X Walk 2 Width (in)	N/A
	X Walk 1 Slope (%)	0.5		X Walk 2 Slope (%)	2.0
	X Walk 1 X Slope (%)	0.6		X Walk 2 X Slope (%)	0.3

N/A	Ramp inside XWalk1?	N/A	N/A	Ramp inside XWalk2?	N/A
	Road Slope (%)	2.0	N/A	Clear Space?	N/A
	Road X Slope (%)	0.8	N/A	Clear Space to XWalk (in)	N/A
N/A	Any Obstructions?	N/A	N/A	Storm Grate/Utility Hazard?	N/A
	Obstruction Type			Storm Grate/Utility Type	
		N/A			N/A
			Yes	Surface Condition? (G/P)	Good

**Remove & Replace Curb Ramp With Two New Directional Ramps or Equivalent.**

Total Cost: \$ 3200.00
