Intersection ID: 10485	Main Street: ANDERSON_ST	Cross Street: THE_PLAZA	Location:	S
ADA ID: 8E4E4E7E1C9C	Ramp Type: Perpendicular	Initial Pass/Fail: Fail	Overall Compliance: No	Severity Score: 21.25

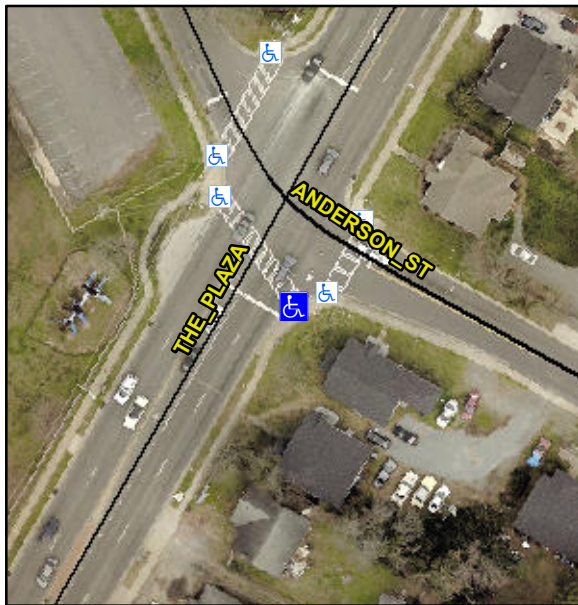
Not Found, R304.5.1, R304.2.2

Possible Solutions:			Compliance	Description	Data	Compliance	Description	Data
Remove & Replace Entire Ramp.	N/A	Ramp Length (in)	27.0	No	Ramp Slope (%)	9.0		
	No	Ramp Width (in)	45.0	Yes	Ramp XSlope (%)	1.6		
	N/A	Flare Type LT	N/A	N/A	Flare Type RT	N/A		
	N/A	Flare Slope LT (%)	N/A	N/A	Flare Slope RT (%)	N/A		
	N/A	Flare Traversable LT?	N/A	N/A	Flare Traversable RT?	N/A		
	N/A	Landing Length (in)	N/A	N/A	DWS Provided?	N/A		
	N/A	Landing Width (in)	N/A	N/A	DWS Contrast?	N/A		
	N/A	Landing Slope (%)	N/A	N/A	DWS Length (in)	N/A		
	N/A	Landing X Slope (%)	N/A	N/A	DWS Full Width?	N/A		
	N/A	Landing Curb? (Y/N)	N/A	N/A	DWS Offset (in)	N/A		
Surveyor Notes: N/A	N/A	Shared Landing?	N/A					
	N/A	Gutter Ponding?	N/A	N/A	Gutter Slope (%)	N/A		
	N/A	Gutter Lip Ht (in)	N/A	N/A	Gutter X Slope (%)	N/A		
	N/A	Painted X Walk1?	Yes	N/A	Painted X Walk2?	N/A		
		X Walk 1 Direction	To NW		X Walk 2 Direction	N/A		
	N/A	X Walk 1 Width (in)	108.0	N/A	X Walk 2 Width (in)	N/A

X Walk 1 Slope (%)	4.7		X Walk 2 Slope (%)	N/A		
		X Walk 1 X Slope (%)	0.5		X Walk 2 X Slope (%)	N/A		
	N/A	Ramp inside XWalk1?	Yes	N/A	Ramp inside XWalk2?	N/A		
		Road Slope (%)	N/A	N/A	Clear Space?	N/A		
PROW/ADA: Not Found, R304.5.1, R304.2.2		Road X Slope (%)	N/A	N/A	Clear Space to XWalk (in)	N/A		
	N/A	Any Obstructions?	N/A	N/A	Storm Grate/Utility Hazard?	N/A		
		Obstruction Type			Storm Grate/Utility Type			
			N/A			N/A		
				Yes	Surface Condition? (G/P)	Good		
	Total Cost:	\$	1850.00

Possible Solutions:

Remove & Replace Entire Ramp.
