Access Compliance Report

Public Rights-of-Way

(Curb Ramps)

Intersection ID: 2762	Main Street: BRADWELL_DR	Cross Street: MCTAGGART_LN	Location: SW
ADA ID: 8E517281D440	Ramp Type: Perpendicular Diagonal	Initial Pass/Fail: Fail	Overall Compliance: No
Severity Score: 21.25			
Codes/Mitigation Info/Possible Solution		Field Measurements/Component Compliance

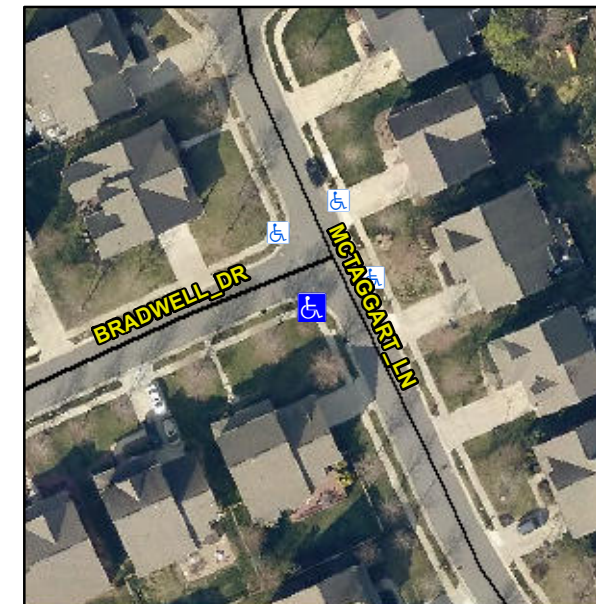
Not Found, R304.5.1, R304.2.2

Compliance	Description	Data	Compliance	Description	Data
N/A	Ramp Length (in)	48.0	No	Ramp Slope (%)	10.4
No	Ramp Width (in)	40.0	Yes	Ramp XSlope (%)	0.6
N/A	Flare Type LT	N/A	N/A	Flare Type RT	N/A
N/A	Flare Slope LT (%)	N/A	N/A	Flare Slope RT (%)	N/A
N/A	Flare Traversable LT?	N/A	N/A	Flare Traversable RT?	N/A
N/A	Landing Length (in)	N/A	N/A	DWS Provided?	N/A
N/A	Landing Width (in)	N/A	N/A	DWS Contrast?	N/A
N/A	Landing Slope (%)	N/A	N/A	DWS Length (in)	N/A
N/A	Landing X Slope (%)	N/A	N/A	DWS Full Width?	N/A
N/A	Landing Curb? (Y/N)	N/A	N/A	DWS Offset (in)	N/A
N/A	Shared Landing?	N/A			
N/A	Gutter Ponding?	N/A	N/A	Gutter Slope (%)	N/A
N/A	Gutter Lip Ht (in)	N/A	N/A	Gutter X Slope (%)	N/A
N/A	Painted X Walk1?	No	N/A	Painted X Walk2?	No
	X Walk 1 Direction	To E		X Walk 2 Direction	To N
N/A	X Walk 1 Width (in)	N/A	N/A	X Walk 2 Width (in)	N/A
	X Walk 1 Slope (%)	3.0		X Walk 2 Slope (%)	2.9
	X Walk 1 X Slope (%)	1.1		X Walk 2 X Slope (%)	0.6

N/A	Ramp inside XWalk1?	N/A	N/A	Ramp inside XWalk2?	N/A
	Road Slope (%)	0.5	N/A	Clear Space?	N/A
	Road X Slope (%)	1.1	N/A	Clear Space to XWalk (in)	N/A
N/A	Any Obstructions?	N/A	N/A	Storm Grate/Utility Hazard?	N/A
	Obstruction Type			Storm Grate/Utility Type	
		N/A			N/A
			Yes	Surface Condition? (G/P)	Good

Possible Solutions:

Remove & Replace Curb Ramp With Two New Directional Ramps or Equivalent.
