Access Compliance Report

Public Rights-of-Way

(Curb Ramps)

Intersection ID: 52303	Main Street: VIBURNUM_CT	Cross Street: SNOWBELL_CT	Location: SE
ADA ID: 8E54022271F3	Ramp Type: Perpendicular	Initial Pass/Fail: Fail	Overall Compliance: No
Codes/Mitigation Info/Possible Solution		Field Measurements/Component Compliance	
Severity Score: 13.75

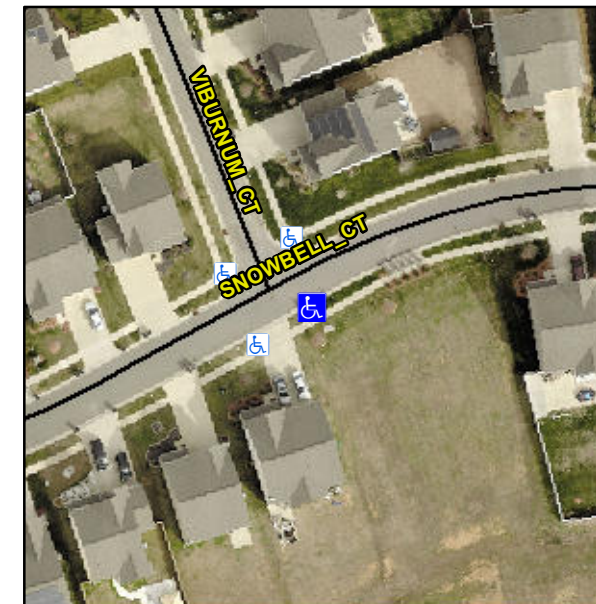
Not Found, R304.2.2, R304.5.3

Compliance	Description	Data	Compliance	Description	Data
N/A	Ramp Length (in)	71.5	No	Ramp Slope (%)	10.0
Yes	Ramp Width (in)	48.0	No	Ramp XSlope (%)	2.3
N/A	Flare Type LT	N/A	N/A	Flare Type RT	N/A
N/A	Flare Slope LT (%)	N/A	N/A	Flare Slope RT (%)	N/A
N/A	Flare Traversable LT?	N/A	N/A	Flare Traversable RT?	N/A
N/A	Landing Length (in)	N/A	N/A	DWS Provided?	N/A
N/A	Landing Width (in)	N/A	N/A	DWS Contrast?	N/A
N/A	Landing Slope (%)	N/A	N/A	DWS Length (in)	N/A
N/A	Landing X Slope (%)	N/A	N/A	DWS Full Width?	N/A
N/A	Landing Curb? (Y/N)	N/A	N/A	DWS Offset (in)	N/A
N/A	Shared Landing?	N/A			
N/A	Gutter Ponding?	N/A	N/A	Gutter Slope (%)	N/A
N/A	Gutter Lip Ht (in)	1.0	N/A	Gutter X Slope (%)	N/A
N/A	Painted X Walk1?	No	N/A	Painted X Walk2?	N/A
	X Walk 1 Direction	To N		X Walk 2 Direction	N/A
N/A	X Walk 1 Width (in)	N/A	N/A	X Walk 2 Width (in)	N/A
	X Walk 1 Slope (%)	2.7		X Walk 2 Slope (%)	N/A
	X Walk 1 X Slope (%)	1.3		X Walk 2 X Slope (%)	N/A

N/A	Ramp inside XWalk1?	N/A	N/A	Ramp inside XWalk2?	N/A
	Road Slope (%)	N/A	N/A	Clear Space?	N/A
	Road X Slope (%)	N/A	N/A	Clear Space to XWalk (in)	N/A
N/A	Any Obstructions?	N/A	N/A	Storm Grate/Utility Hazard?	N/A
	Obstruction Type			Storm Grate/Utility Type	
		N/A			N/A
			Yes	Surface Condition? (G/P)	Good

Possible Solutions:

Remove & Replace Entire Ramp.

Total Cost: \$ 1850.00
