Access Compliance Report

Public Rights-of-Way

(Curb Ramps)

Intersection ID: 30083	Main Street: J_W_CLAY_BV	Cross Street: VILLAGE_SHOPPING_CENTER_DR_S	Location: NE
ADA ID: 8E5846966F39	Ramp Type: Perpendicular	Initial Pass/Fail: Fail	Overall Compliance: No
Severity Score: 17.5			
Codes/Mitigation Info/Possible Solution		Field Measurements/Component Compliance

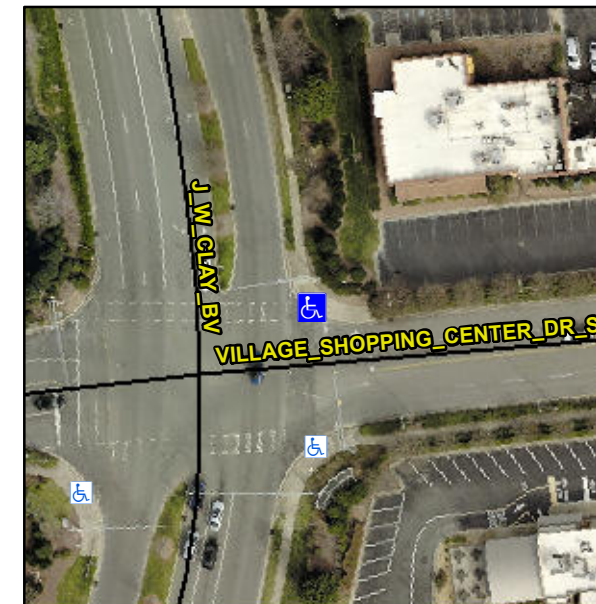
Compliance	Description	Data	Compliance	Description	Data
N/A	Ramp Length (in)	112.0	Yes	Ramp Slope (%)	7.2
No	Ramp Width (in)	33.0	Yes	Ramp XSlope (%)	1.3
N/A	Flare Type LT	N/A	N/A	Flare Type RT	N/A
N/A	Flare Slope LT (%)	N/A	N/A	Flare Slope RT (%)	N/A
N/A	Flare Traversable LT?	N/A	N/A	Flare Traversable RT?	N/A
N/A	Landing Length (in)	N/A	N/A	DWS Provided?	N/A
N/A	Landing Width (in)	N/A	N/A	DWS Contrast?	N/A
N/A	Landing Slope (%)	N/A	N/A	DWS Length (in)	N/A
N/A	Landing X Slope (%)	N/A	N/A	DWS Full Width?	N/A
N/A	Landing Curb? (Y/N)	N/A	N/A	DWS Offset (in)	N/A
N/A	Shared Landing?	N/A			
N/A	Gutter Ponding?	N/A	N/A	Gutter Slope (%)	N/A
N/A	Gutter Lip Ht (in)	N/A	N/A	Gutter X Slope (%)	N/A
N/A	Painted X Walk1?	No	N/A	Painted X Walk2?	N/A
	X Walk 1 Direction	To S		X Walk 2 Direction	N/A
N/A	X Walk 1 Width (in)	N/A	N/A	X Walk 2 Width (in)	N/A
	X Walk 1 Slope (%)	1.6		X Walk 2 Slope (%)	N/A
	X Walk 1 X Slope (%)	3.3		X Walk 2 X Slope (%)	N/A

N/A	Ramp inside XWalk1?	N/A	N/A	Ramp inside XWalk2?	N/A
	Road Slope (%)	N/A	N/A	Clear Space?	N/A
	Road X Slope (%)	N/A	N/A	Clear Space to XWalk (in)	N/A
N/A	Any Obstructions?	N/A	N/A	Storm Grate/Utility Hazard?	N/A
	Obstruction Type			Storm Grate/Utility Type	
		N/A			N/A
		Yes		Surface Condition? (G/P)	Good

Possible Solutions:

Remove & Replace Entire Ramp.
