## **Access Compliance Report Public Rights-of-Way** (Curb Ramps)

Main Street: PROVIDENCE RD Intersection ID: 27177 **Cross Street: MCKEE RD** Location: SE Initial Pass/Fail: Fail **Overall Compliance: No** ADA ID: 8E5A492A6CDD Ramp Type: Perpendicular **Severity Score:** 8.75

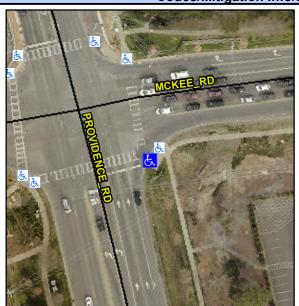
Possible Solution			rieia ivie
Possible Solutions:	Compl	iance	Description
Remove & Replace Entire Ramp.	N/A	Ram	Length (in)
·	No	Ram	Width (in)
	N/A	Flare	Type LT
	N/A	Flare	Slope LT (%)
	N/A	Flare	Traversable LT
	N/A	Land	ing Length (in)
Surveyor Notes:	N/A	Land	ing Width (in)
N/A	N/A	Land	ing Slope (%)
	N/A	Land	ing X Slope (%
	N/A	Land	ing Curb? (Y/N
	N/A	Share	ed Landing?
PROW/ADA:	N/A	Gutte	er Ponding?
Not Found, R304.5.1	N/A	Gutte	er Lip Ht (in)
	N/A	Paint	ed X Walk1?
		X Wa	lk 1 Direction
	N/A	X Wa	lk 1 Width (in)
		X Wa	lk 1 Slope (%)
		X Wa	lk 1 X Slope (%
	N/A	Ram	o inside XWalk
