Access Compliance Report

Public Rights-of-Way (Curb Ramps)

Intersection ID: 21114	Main Street: BENT_BRANCH_RD	Cross Street: CARMEL_RD	Location: SE
ADA ID: 8E5E7207F785	Ramp Type: Directional1	Initial Pass/Fail: Fail	Overall Compliance: No
		Severity Score: 22.5

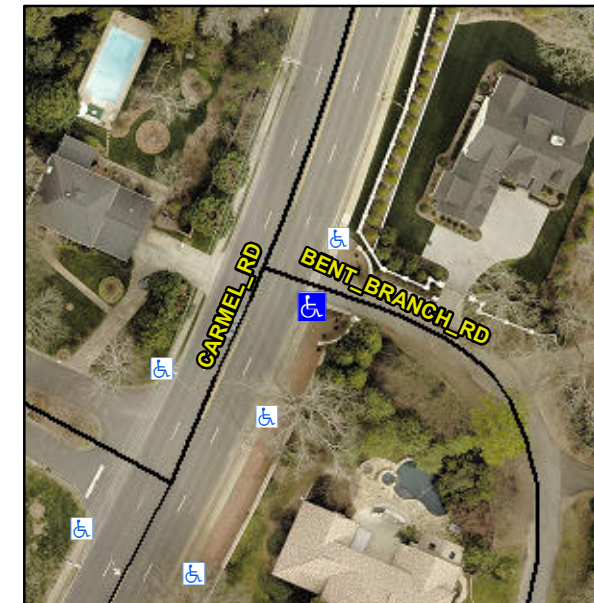
R304.5.1, R304.2.2

Compliance	Description	Data	Compliance	Description	Data
N/A	Ramp Length (in)	80.0	N/A	Grade Break?	N/A
No	Ramp Width (in)	47.0	N/A	Grade Break Slope (%)	0.0
No	Ramp Slope (%)	9.2	N/A	Grade Break XSlope (%)	0.0
Yes	Ramp XSlope (%)	2.8			
N/A	Flare Type LT	N/A	N/A	Flare Type RT	N/A
N/A	Flare Slope LT (%)	N/A	N/A	Flare Slope RT (%)	0.0
N/A	Flare Traversable LT?	N/A	N/A	Flare Traversable RT?	N/A
N/A	Landing Length (in)	0.0	N/A	DWS Provided?	N/A
N/A	Landing Width (in)	0.0	N/A	DWS Contrast?	N/A
N/A	Landing Slope (%)	0.0	N/A	DWS Length (in)	N/A
N/A	Landing X Slope (%)	0.0	N/A	DWS Full Width?	N/A
N/A	Landing Curb? (Y/N)	N/A	N/A	DWS Offset LT (in)	N/A
N/A	Shared Landing?	N/A	N/A	DWS Offset RT (in)	N/A
N/A	Gutter Ponding?	0.0	N/A	Gutter Slope (%)	N/A
N/A	Gutter Lip Ht (in)	0.0	N/A	Gutter X Slope (%)	N/A
N/A	Painted X Walk1?	No		Road Slope (%)	0.0
	X Walk 1 Direction	To NE		Road X Slope (%)	6.9
	X Walk 1 Width (in)	N/A		Clear Space?	N/A

X Walk 1 Slope (%)	0.0	N/A	Clear Space to XWalk (in)	N/A
	X Walk 1 X Slope (%)	6.9	N/A	Storm Grate/Utility Hazard?	N/A
N/A	Ramp inside XWalk1?	N/A		Storm Grate/Utility Type	
N/A	Any Obstructions?	N/A			N/A
	Obstruction Type		Yes	Surface Condition? (G/P)	Good
			N/A	Curb Slope (%)	6.7

Remove & Replace Entire Ramp.
