Access Compliance Report

Public Rights-of-Way

(Curb Ramps)

Intersection ID: 48263	Main Street: EAST_ARBORS_DR	Cross Street: SENATOR_ROYALL_DR	Location:	E
ADA ID: 8E600CCB4F0F	Ramp Type: Perpendicular	Initial Pass/Fail: Fail	Overall Compliance: No	Severity Score: 25

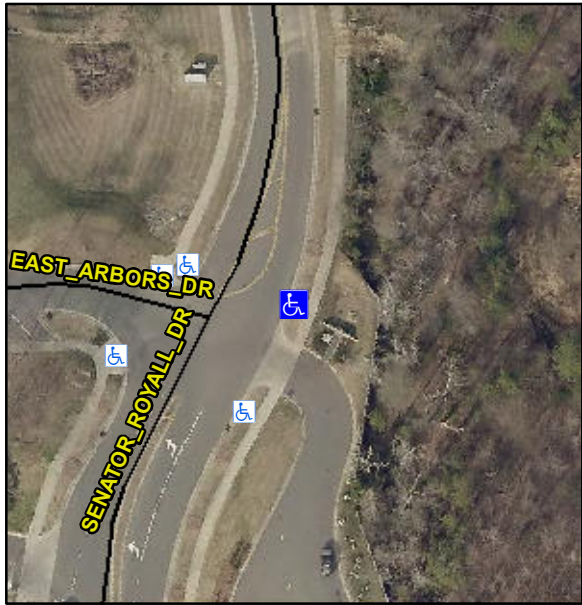
<p>Street 1 Name SENATOR ROYALL DR</p> <p>Stop Condition-Street 2 None</p> <p>Street 2 Name N/A</p> <p>Stop Condition-Street 1 N/A</p>	Possible Solutions:		Compliance	Description	Data	Compliance	Description	Data
	Remove & Replace Entire Ramp.		N/A	Ramp Length (in)	96.0	No	Ramp Slope (%)	10.5
			Yes	Ramp Width (in)	48.0	No	Ramp XSlope (%)	5.1
			N/A	Flare Type LT	N/A	N/A	Flare Type RT	N/A
			N/A	Flare Slope LT (%)	N/A	N/A	Flare Slope RT (%)	N/A
			N/A	Flare Traversable LT?	N/A	N/A	Flare Traversable RT?	N/A
			N/A	Landing Length (in)	N/A	N/A	DWS Provided?	N/A
			N/A	Landing Width (in)	N/A	N/A	DWS Contrast?	N/A
			N/A	Landing Slope (%)	N/A	N/A	DWS Length (in)	N/A
			N/A	Landing X Slope (%)	N/A	N/A	DWS Full Width?	N/A
Surveyor Notes:		N/A	N/A	Landing Curb? (Y/N)	N/A	N/A	DWS Offset (in)	N/A
PROW/ADA:		R304.2.2, R304.5.3	N/A	Shared Landing?	N/A
