Access Compliance Report

Public Rights-of-Way

(Curb Ramps)

Intersection ID: 20918	Main Street: FOLGER_DR	Cross Street: WINGRAVE_DR	Location: W
ADA ID: 8E6A615A85B0	Ramp Type: Perpendicular Diagonal	Initial Pass/Fail: Fail	Overall Compliance: No
		Severity Score: 10

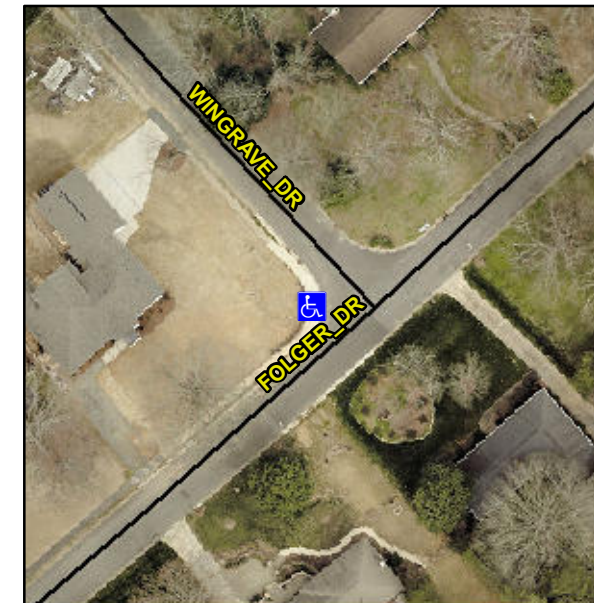
Not Found, R304.5.1, R304.5.3

Compliance	Description	Data	Compliance	Description	Data
N/A	Ramp Length (in)	47.0	Yes	Ramp Slope (%)	6.8
No	Ramp Width (in)	40.0	No	Ramp XSlope (%)	3.6
N/A	Flare Type LT	N/A	N/A	Flare Type RT	N/A
N/A	Flare Slope LT (%)	N/A	N/A	Flare Slope RT (%)	N/A
N/A	Flare Traversable LT?	N/A	N/A	Flare Traversable RT?	N/A
N/A	Landing Length (in)	N/A	N/A	DWS Provided?	N/A
N/A	Landing Width (in)	N/A	N/A	DWS Contrast?	N/A
N/A	Landing Slope (%)	N/A	N/A	DWS Length (in)	N/A
N/A	Landing X Slope (%)	N/A	N/A	DWS Full Width?	N/A
N/A	Landing Curb? (Y/N)	N/A	N/A	DWS Offset (in)	N/A
N/A	Shared Landing?	N/A			
N/A	Gutter Ponding?	N/A	N/A	Gutter Slope (%)	N/A
N/A	Gutter Lip Ht (in)	N/A	N/A	Gutter X Slope (%)	N/A
N/A	Painted X Walk1?	No	N/A	Painted X Walk2?	No
	X Walk 1 Direction	To SE		X Walk 2 Direction	To NE
N/A	X Walk 1 Width (in)	N/A	N/A	X Walk 2 Width (in)	N/A
	X Walk 1 Slope (%)	2.6		X Walk 2 Slope (%)	3.4
	X Walk 1 X Slope (%)	3.3		X Walk 2 X Slope (%)	1.2

N/A	Ramp inside XWalk1?	N/A	N/A	Ramp inside XWalk2?	N/A
	Road Slope (%)	0.2	N/A	Clear Space?	N/A
	Road X Slope (%)	5.0	N/A	Clear Space to XWalk (in)	N/A
N/A	Any Obstructions?	N/A	N/A	Storm Grate/Utility Hazard?	N/A
	Obstruction Type			Storm Grate/Utility Type	
		N/A			N/A
			Yes	Surface Condition? (G/P)	Good

Remove & Replace Curb Ramp With Two New Directional Ramps or Equivalent.
