## Access Compliance Report Public Rights-of-Way (Curb Ramps)

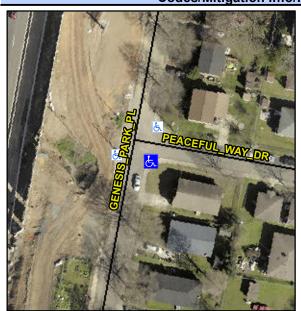
Intersection ID: 9547 Main Street: GENESIS\_PARK\_PL Cross Street: PEACEFUL\_WAY\_DR Location: SE

R304.5.1, R304.2.2, R304.5.3

Total Cost: \$ 3200.00

Street 1 Name
Stop Condition-Street 2
Street 2 Name
Stop Condition-Street 1
