Access Compliance Report

Public Rights-of-Way

(Curb Ramps)

Intersection ID: 2746	Main Street: BELL'S_MILL_DR	Cross Street: TANAGER_LN	Location:	N
ADA ID: 8E7E510AC9FB	Ramp Type: Perpendicular	Initial Pass/Fail: Fail	Overall Compliance: No	Severity Score: 12.5

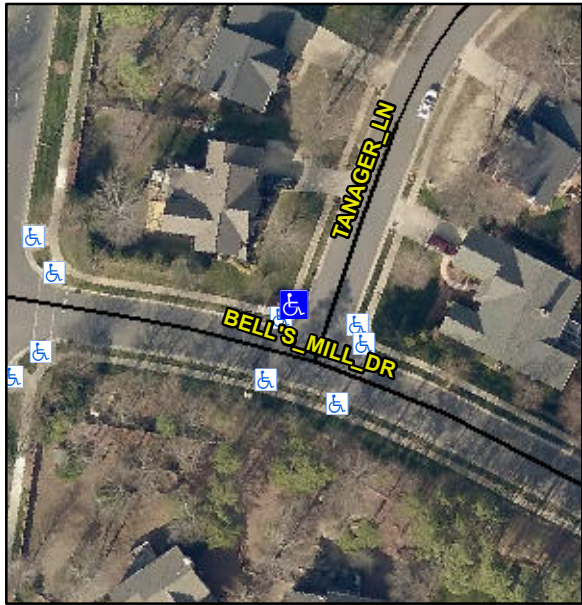
Possible Solutions:		Compliance	Description	Data	Compliance	Description	Data
	Remove & Replace Entire Ramp.		N/A	Ramp Length (in)	44.0	No	Ramp Slope (%)	11.7
			Yes	Ramp Width (in)	55.0	Yes	Ramp XSlope (%)	1.2
			N/A	Flare Type LT	N/A	N/A	Flare Type RT	N/A
			N/A	Flare Slope LT (%)	N/A	N/A	Flare Slope RT (%)	N/A
			N/A	Flare Traversable LT?	N/A	N/A	Flare Traversable RT?	N/A
			N/A	Landing Length (in)	N/A	N/A	DWS Provided?	N/A
			N/A	Landing Width (in)	N/A	N/A	DWS Contrast?	N/A
			N/A	Landing Slope (%)	N/A	N/A	DWS Length (in)	N/A
			N/A	Landing X Slope (%)	N/A	N/A	DWS Full Width?	N/A
Surveyor Notes:			N/A	Landing Curb? (Y/N)	N/A	N/A	DWS Offset (in)	N/A
PROW/ADA:			N/A	Shared Landing?	N/A			
R304.2.2			N/A	Gutter Ponding?	Yes	N/A	Gutter Slope (%)	N/A
			N/A	Gutter Lip Ht (in)	N/A	N/A	Gutter X Slope (%)	N/A
			N/A	Painted X Walk1?	No	N/A	Painted X Walk2?	N/A

X Walk 1 Direction	To SE		X Walk 2 Direction	N/A
			N/A	X Walk 1 Width (in)	N/A	N/A	X Walk 2 Width (in)	N/A
				X Walk 1 Slope (%)	2.3		X Walk 2 Slope (%)	N/A
				X Walk 1 X Slope (%)	1.2		X Walk 2 X Slope (%)	N/A
			N/A	Ramp inside XWalk1?	N/A	N/A	Ramp inside XWalk2?	N/A
				Road Slope (%)	N/A	N/A	Clear Space?	N/A
				Road X Slope (%)	N/A	N/A	Clear Space to XWalk (in)	N/A
			N/A	Any Obstructions?	N/A	N/A	Storm Grate/Utility Hazard?	N/A
				Obstruction Type			Storm Grate/Utility Type	
					N/A			N/A
						Yes	Surface Condition? (G/P)	Good
