Access Compliance Report Public Rights-of-Way (Curb Ramps)

Intersection ID: 9575 Main Street: CATALINA AV **Cross Street: WINSTON ST** Location: SW **Overall Compliance: No ADA ID: 8E84CEF75288** Ramp Type: Combination2 Initial Pass/Fail: Fail Severity Score: 58.75

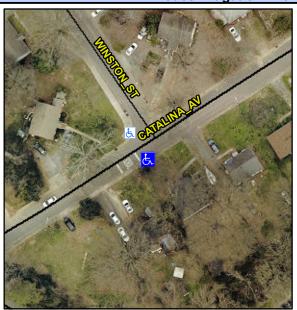
Compliance Description Possible Solutions: N/A Remove & Replace Entire Ramp. N/A N/A N/A N/A Yes Surveyor Notes: N/A LT RP < 5% N/A N/A N/A N/A PROW/ADA: N/A R304.5.1, R304.2.2, R304.5.3 N/A N/A N/A N/A N/A N/A
