Access Compliance Report Public Rights-of-Way (Curb Ramps)

Intersection ID: 6370 Main Street: LAKE_RD **Cross Street: MILHAVEN_LN** Location: SE Severity Score: 21.25 **Overall Compliance: No ADA ID: 8E902F06FDE6** Ramp Type: Perpendicular Initial Pass/Fail: Fail

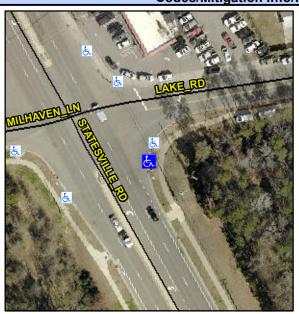
Field Measurements/Component Compliance							
Compl	iance Description	Data	Comp	liance	Description	Data	
N/A	Ramp Length (in)	105.0	No	Ramp	Slope (%)	8.8	
No	Ramp Width (in)	47.0	Yes	Yes Ramp XSlope (%)		1.6	
N/A	Flare Type LT	N/A	N/A	N/A Flare Type RT		N/A	
N/A	Flare Slope LT (%)	N/A	N/A	I/A Flare Slope RT (%)			
N/A	Flare Traversable LT?	N/A	N/A	Flare	Traversable RT?	N/A	
N/A	Landing Length (in)	N/A	N/A	DWS Provided?		N/A	
N/A	Landing Width (in)	N/A	N/A	DWS	Contrast?	N/A	
N/A	Landing Slope (%)	N/A	N/A	DWS	Length (in)	N/A	
N/A	Landing X Slope (%)	N/A	N/A	DWS	Full Width?	N/A	
N/A	Landing Curb? (Y/N)	N/A	N/A	DWS	Offset (in)	N/A	
N/A	Shared Landing?	N/A					
N/A	Gutter Ponding?	N/A	N/A	Gutte	r Slope (%)	N/A	
N/A	Gutter Lip Ht (in)	N/A	N/A	Gutte	r X Slope (%)	N/A	
N/A	Painted X Walk1?	No	N/A	Painte	ed X Walk2?	N/A	
	X Walk 1 Direction	To W		X Wa	lk 2 Direction	N/A	
N/A	X Walk 1 Width (in)	N/A	N/A	X Wa	lk 2 Width (in)	N/A

Possible Solutions: Remove & Replace Entire Ramp. Surveyor Notes: N/A PROW/ADA: Not Found, R304.5.1, R304.2.2
