# Access Compliance Report

## Public Rights-of-Way

| Intersection ID: 52599 | Main Street: W_TYVOLA_RD | Cross Street: POTOMAC_RIVER_PY | Location: NW |
| ADA ID: 8E929AD83A82 | Ramp Type: Perpendicular Diagonal | Initial Pass/Fail: Pass | Overall Compliance: No |

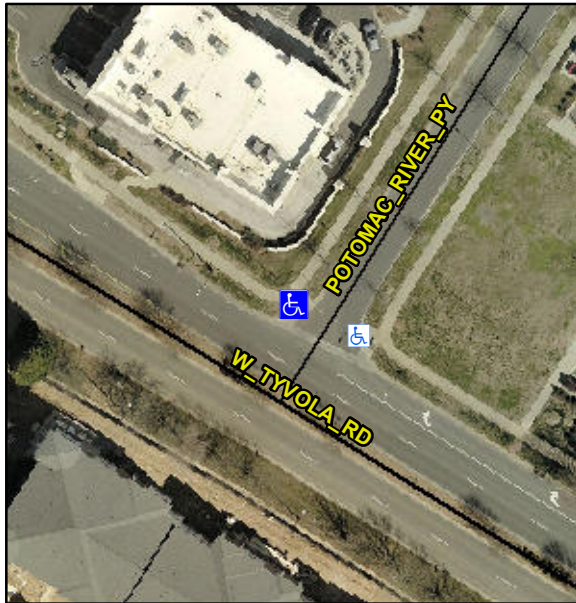
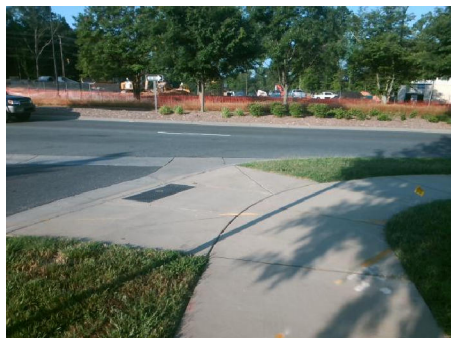
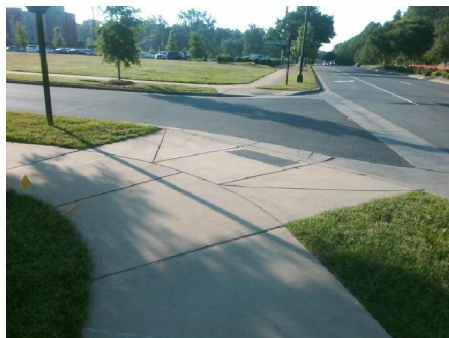
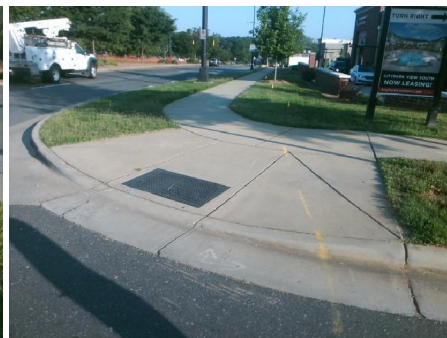
| | | | Severity Score: 2.75 |

**Not Found, R304.5.3, R305.1.4, R305.2**

| Compliance | Description | Data | Compliance | Description | Data |
|---|---|---|---|---|---|
| Yes | Ramp Width (in) | 50.0 | No | Ramp XSlope (%) | 2.6 |
| No | Landing X Slope (%) | 2.1 | No | DWS Full Width? | No |
| N/A | Landing Curb? (Y/N) | No | No | DWS Offset (in) | 5.5 |

**Remove & Replace Curb Ramp With Two New Directional Ramps or Equivalent.**

Total Cost: \$ **3200.00**
