Access Compliance Report

Public Rights-of-Way

(Curb Ramps)

Intersection ID: 31369	Main Street: HAGERSTONE_WY	Cross Street: MCINTYRE_RIDGE_DR	Location: SE
ADA ID: 8E9B759654E8	Ramp Type: BlendTrans2	Initial Pass/Fail: Fail	Overall Compliance: No
Severity Score: 21.25			
Codes/Mitigation Info/Possible Solution		Field Measurements/Component Compliance

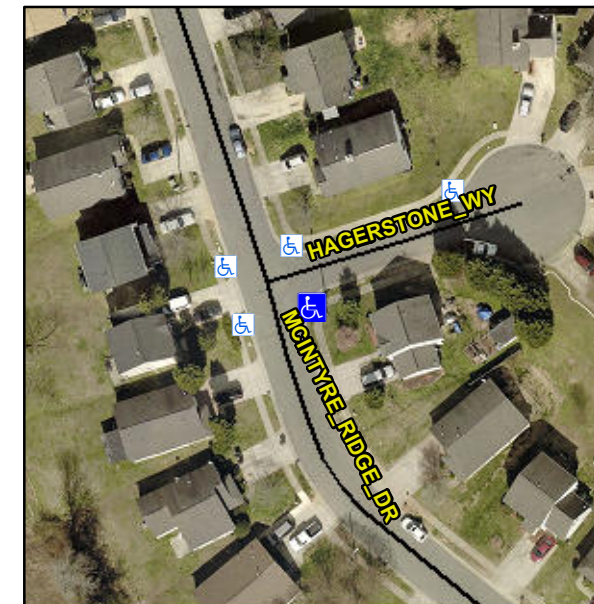
Compliance	Description	Data	Compliance	Description	Data
N/A	Ramp Length (in)	94.0	Yes	BlendTrans Slope (%)	3.7
No	Ramp Width (in)	41.5	No	BlendTrans XSlope (%)	5.1
N/A	Flare Type LT	N/A	N/A	Flare Type RT	N/A
N/A	Flare Slope LT (%)	N/A	N/A	Flare Slope RT (%)	N/A
N/A	Flare Traversable LT?	N/A	N/A	Flare Traversable RT?	N/A
N/A	Landing Length (in)	N/A	N/A	DWS Provided?	N/A
N/A	Landing Width (in)	N/A	N/A	DWS Contrast?	N/A
N/A	Landing Slope (%)	N/A	N/A	DWS Length (in)	N/A
N/A	Landing X Slope (%)	N/A	N/A	DWS Full Width?	N/A
N/A	Landing Curb? (Y/N)	N/A	N/A	DWS Offset (in)	N/A
N/A	Shared Landing?	N/A			
N/A	Gutter Ponding?	N/A	N/A	Gutter Slope (%)	N/A
N/A	Gutter Lip Ht (in)	N/A	N/A	Gutter X Slope (%)	N/A
N/A	Painted X Walk1?	No	N/A	Painted X Walk2?	No
	X Walk 1 Direction	To N		X Walk 2 Direction	To W
	X Walk 1 Width (in)	N/A		X Walk 2 Width (in)	N/A
	X Walk 1 Slope (%)	1.0		X Walk 2 Slope (%)	1.0
	X Walk 1 X Slope (%)	2.7		X Walk 2 X Slope (%)	3.0

N/A	Ramp inside XWalk1?	N/A	N/A	Ramp inside XWalk2?	N/A
	Road Slope (%)	3.4		Clear Space?	N/A
	Road X Slope (%)	0.9	N/A	Clear Space to XWalk (in)	N/A
N/A	Any Obstructions?	N/A	N/A	Storm Grate/Utility Hazard?	N/A
	Obstruction Type			Storm Grate/Utility Type	
		N/A			N/A
			Yes	Surface Condition? (G/P)	Good
			N/A	Curb Slope (%)	1.9

Possible Solutions:

Remove & Replace Curb Ramp With Two New Directional Ramps or Equivalent.

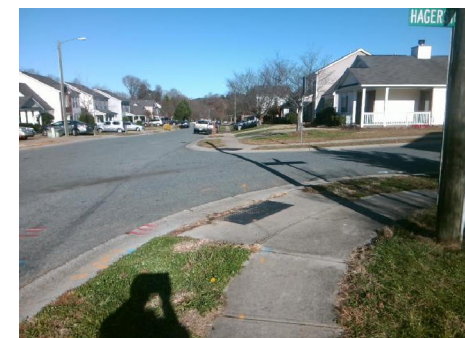
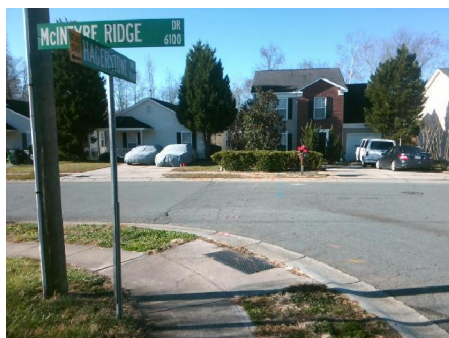
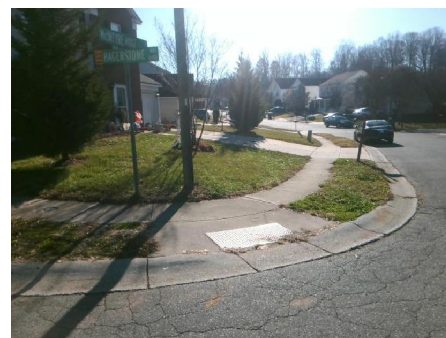
Street 1 Name **HAGERSTONE WY**
 Stop Condition-Street 1 **StopSign**
 Street 2 Name **MCINTYRE RIDGE DR**
 Stop Condition-Street 2 **None**
