Intersection ID: 52494	Main Street: WEST_BV	Cross Street: NEW_RENAISSANCE_WY	Location:	NW
ADA ID: 8EA004A362BE	Ramp Type: Perpendicular Diagonal	Initial Pass/Fail: Fail	Overall Compliance: No	Severity Score: 12.5

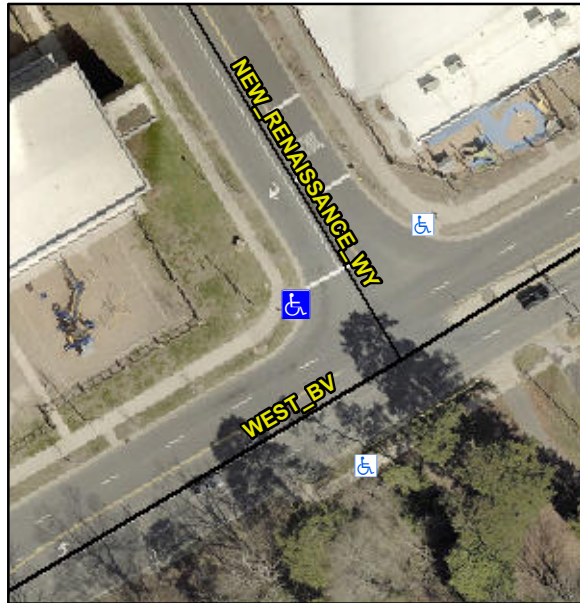
Not Found, R304.5.3

Compliance	Description	Data	Compliance	Description	Data
N/A	Ramp Length (in)	100.0	Yes	Ramp Slope (%)	5.8
Yes	Ramp Width (in)	48.0	No	Ramp XSlope (%)	5.9
N/A	Flare Type LT	N/A	N/A	Flare Type RT	N/A
N/A	Flare Slope LT (%)	N/A	N/A	Flare Slope RT (%)	N/A
N/A	Flare Traversable LT?	N/A	N/A	Flare Traversable RT?	N/A
N/A	Landing Length (in)	N/A	N/A	DWS Provided?	N/A
N/A	Landing Width (in)	N/A	N/A	DWS Contrast?	N/A
N/A	Landing Slope (%)	N/A	N/A	DWS Length (in)	N/A
N/A	Landing X Slope (%)	N/A	N/A	DWS Full Width?	N/A
N/A	Landing Curb? (Y/N)	N/A	N/A	DWS Offset (in)	N/A
N/A	Shared Landing?	N/A			
N/A	Gutter Ponding?	N/A	N/A	Gutter Slope (%)	N/A
N/A	Gutter Lip Ht (in)	N/A	N/A	Gutter X Slope (%)	N/A
N/A	Painted X Walk1?	No	N/A	Painted X Walk2?	No
	X Walk 1 Direction	To S		X Walk 2 Direction	To E
N/A	X Walk 1 Width (in)	N/A	N/A	X Walk 2 Width (in)	N/A
	X Walk 1 Slope (%)	1.1		X Walk 2 Slope (%)	1.9
	X Walk 1 X Slope (%)	2.9		X Walk 2 X Slope (%)	2.1

N/A	Ramp inside XWalk1?	N/A	N/A	Ramp inside XWalk2?	N/A
	Road Slope (%)	3.4	N/A	Clear Space?	N/A
	Road X Slope (%)	2.9	N/A	Clear Space to XWalk (in)	N/A
N/A	Any Obstructions?	N/A	N/A	Storm Grate/Utility Hazard?	N/A
	Obstruction Type			Storm Grate/Utility Type	
		N/A			N/A
			Yes	Surface Condition? (G/P)	Good

Remove & Replace Curb Ramp With Two New Directional Ramps or Equivalent.

Total Cost: \$ 3200.00

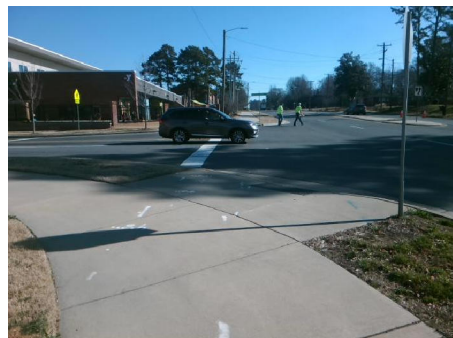
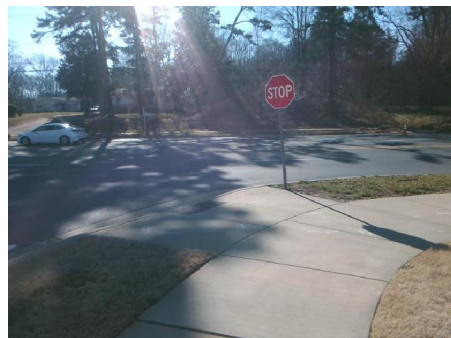
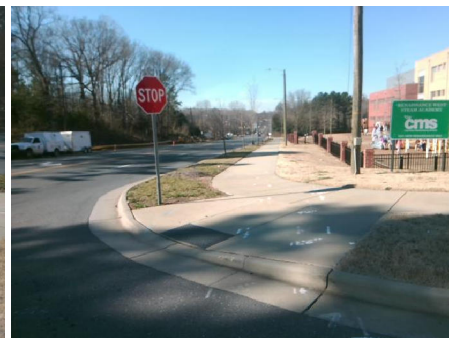
Street 1 Name	WEST BV
Stop Condition-Street 2	None
Street 2 Name	NEW RENAISSANCE WY
Stop Condition-Street 1	StopSign
