Access Compliance Report

Public Rights-of-Way

(Curb Ramps)

Intersection ID: 27190	Main Street: BALLANTYNE COMMONS PY	Cross Street: WOODVIEW CR	Location: SW
ADA ID: 8EAC8238A1A0	Ramp Type: Perpendicular Diagonal	Initial Pass/Fail: Fail	Overall Compliance: No
Severity Score: 12.5			
Codes/Mitigation Info/Possible Solution		Field Measurements/Component Compliance

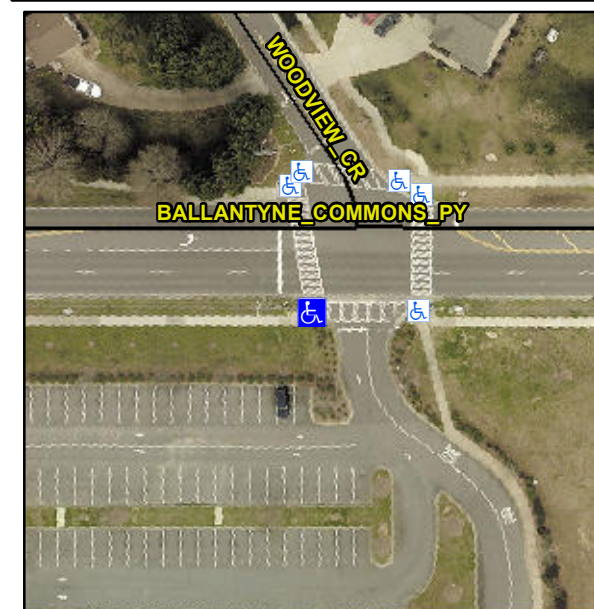
Not Found, R304.2.2

Compliance	Description	Data	Compliance	Description	Data
N/A	Ramp Length (in)	95.0	No	Ramp Slope (%)	8.7
Yes	Ramp Width (in)	49.0	Yes	Ramp XSlope (%)	0.9
N/A	Flare Type LT	N/A	N/A	Flare Type RT	N/A
N/A	Flare Slope LT (%)	N/A	N/A	Flare Slope RT (%)	N/A
N/A	Flare Traversable LT?	N/A	N/A	Flare Traversable RT?	N/A
N/A	Landing Length (in)	N/A	N/A	DWS Provided?	N/A
N/A	Landing Width (in)	N/A	N/A	DWS Contrast?	N/A
N/A	Landing Slope (%)	N/A	N/A	DWS Length (in)	N/A
N/A	Landing X Slope (%)	N/A	N/A	DWS Full Width?	N/A
N/A	Landing Curb? (Y/N)	N/A	N/A	DWS Offset (in)	N/A
N/A	Shared Landing?	N/A			
N/A	Gutter Ponding?	N/A	N/A	Gutter Slope (%)	N/A
N/A	Gutter Lip Ht (in)	N/A	N/A	Gutter X Slope (%)	N/A
N/A	Painted X Walk1?	Yes	N/A	Painted X Walk2?	Yes
	X Walk 1 Direction	To E		X Walk 2 Direction	To N
N/A	X Walk 1 Width (in)	105.0	N/A	X Walk 2 Width (in)	112.0
	X Walk 1 Slope (%)	3.7		X Walk 2 Slope (%)	3.8
	X Walk 1 X Slope (%)	5.3		X Walk 2 X Slope (%)	1.2

N/A	Ramp inside XWalk1?	Yes	N/A	Ramp inside XWalk2?	Yes
	Road Slope (%)	5.6	N/A	Clear Space?	N/A
	Road X Slope (%)	8.3	N/A	Clear Space to XWalk (in)	N/A
N/A	Any Obstructions?	N/A	N/A	Storm Grate/Utility Hazard?	N/A
	Obstruction Type			Storm Grate/Utility Type	
		N/A			N/A
		Yes		Surface Condition? (G/P)	Good

Remove & Replace Curb Ramp With Two New Directional Ramps or Equivalent.

Total Cost: \$ 3200.00
