## Access Compliance Report Public Rights-of-Way (Curb Ramps)

Intersection ID: 18709Main Street:FOX\_RUN\_DRCross Street:MONROE\_RDLocation:NEADA ID: 8EAFC0E88ADDRamp Type:Perpendicular DiagonalInitial Pass/Fail:FailOverall Compliance:NoSeverity Score:50

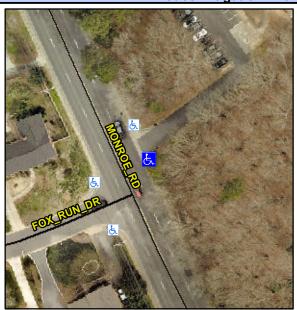
Field Measurements/Component Compliance							
	Compliance Description		Data	Comp	liance Description	Data	
	N/A	Ramp Length (in)	60.0	No	Ramp Slope (%)	12.8	
	Yes	Ramp Width (in)	48.0	No	Ramp XSlope (%)	10.1	
	N/A	Flare Type LT	N/A	N/A	Flare Type RT	N/A	
	N/A	Flare Slope LT (%)	N/A	N/A	Flare Slope RT (%)	N/A	
	N/A	Flare Traversable LT?	N/A	N/A	Flare Traversable RT?	N/A	
	N/A	Landing Length (in)	N/A	N/A	DWS Provided?	N/A	
	N/A	Landing Width (in)	N/A	N/A	DWS Contrast?	N/A	
	N/A	Landing Slope (%)	N/A	N/A	DWS Length (in)	N/A	
	N/A	Landing X Slope (%)	N/A	N/A	DWS Full Width?	N/A	
	N/A	Landing Curb? (Y/N)	N/A	N/A	DWS Offset (in)	N/A	
	N/A	Shared Landing?	N/A				
	N/A	Gutter Ponding?	N/A	N/A	Gutter Slope (%)	N/A	
	N/A	Gutter Lip Ht (in)	N/A	N/A	Gutter X Slope (%)	N/A	
	N/A	Painted X Walk1?	No	N/A	Painted X Walk2?	No	
		X Walk 1 Direction	To N		X Walk 2 Direction	To W	
	N/A	X Walk 1 Width (in)	N/A	N/A	X Walk 2 Width (in)	N/A

X Walk 1 Slope (%)	3.3		X Walk 2 Slope (%)	2.4	
		X Walk 1 X Slope (%)	11.0		X Walk 2 X Slope (%)	2.8	
	N/A	Ramp inside XWalk1?	N/A	N/A	Ramp inside XWalk2?	N/A	
		Road Slope (%)	9.8	N/A	Clear Space?	N/A	
		Road X Slope (%)	5.5	N/A	Clear Space to XWalk (in)	N/A	
	N/A	Any Obstructions?	N/A	N/A	Storm Grate/Utility Hazard?	N/A	
		Obstruction Type			Storm Grate/Utility Type

Possible Solutions:
Remove & Replace Curb Ramp With Two New Directional Ramps or Equivalent.
Surveyor Notes: N/A
PROW/ADA: Not Found, R304.2.2, R304.5.3

Total Cost: \$ 3200.00
