Intersection ID: 31480	Main Street: FLAGLER_LN	Cross Street: SUNMAN_RD	Location:	NE
ADA ID: 8EC06BB9EBB1	Ramp Type: BlendTrans1	Initial Pass/Fail: Fail	Overall Compliance: No	Severity Score: 33.75

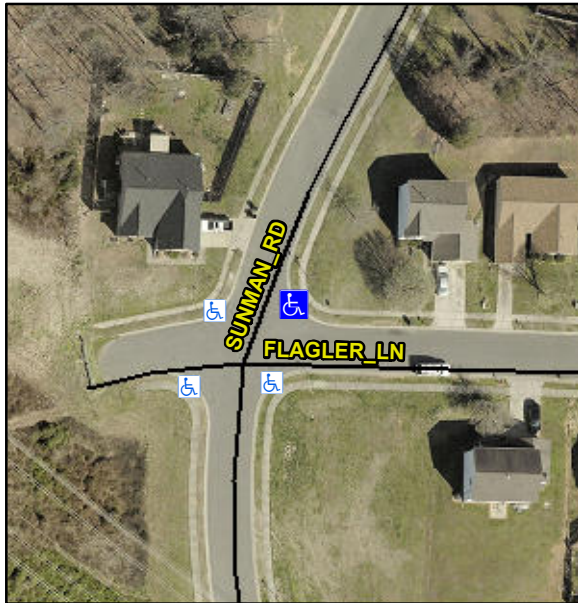
Not Found, R304.5.1, R304.5.3

Compliance	Description	Data	Compliance	Description	Data
N/A	Ramp Length (in)	29.5	Yes	BlendTrans Slope (%)	2.7
No	Ramp Width (in)	41.5	No	BlendTrans XSlope (%)	8.6
N/A	Flare Type LT	N/A	N/A	Flare Type RT	N/A
N/A	Flare Slope LT (%)	N/A	N/A	Flare Slope RT (%)	N/A
N/A	Flare Traversable LT?	N/A	N/A	Flare Traversable RT?	N/A
N/A	Landing Length (in)	N/A	N/A	DWS Provided?	N/A
N/A	Landing Width (in)	N/A	N/A	DWS Contrast?	N/A
N/A	Landing Slope (%)	N/A	N/A	DWS Length (in)	N/A
N/A	Landing X Slope (%)	N/A	N/A	DWS Full Width?	N/A
N/A	Landing Curb? (Y/N)	N/A	N/A	DWS Offset (in)	N/A
N/A	Shared Landing?	N/A			
N/A	Gutter Ponding?	N/A	N/A	Gutter Slope (%)	N/A
N/A	Gutter Lip Ht (in)	N/A	N/A	Gutter X Slope (%)	N/A
N/A	Painted X Walk1?	No	N/A	Painted X Walk2?	No
	X Walk 1 Direction	To W		X Walk 2 Direction	To S
	X Walk 1 Width (in)	N/A		X Walk 2 Width (in)	N/A
	X Walk 1 Slope (%)	2.4		X Walk 2 Slope (%)	3.1
	X Walk 1 X Slope (%)	5.8		X Walk 2 X Slope (%)	4.7

N/A	Ramp inside XWalk1?	N/A	N/A	Ramp inside XWalk2?	N/A
	Road Slope (%)	6.6		Clear Space?	N/A
	Road X Slope (%)	1.2	N/A	Clear Space to XWalk (in)	N/A
N/A	Any Obstructions?	N/A	N/A	Storm Grate/Utility Hazard?	N/A
	Obstruction Type			Storm Grate/Utility Type	
		N/A			N/A
			Yes	Surface Condition? (G/P)	Good
			No	Curb Slope (%)	5.4

Remove & Replace Curb Ramp With Two New Directional Ramps or Equivalent.
