Access Compliance Report

Public Rights-of-Way

(Curb Ramps)

Intersection ID: N/A	Main Street: BALTUSROL_LN	Cross Street: N/A	Location: E
ADA ID: 8EC7ABCB1594	Ramp Type: Perpendicular	Initial Pass/Fail: Fail	Overall Compliance: No
		Severity Score: 10

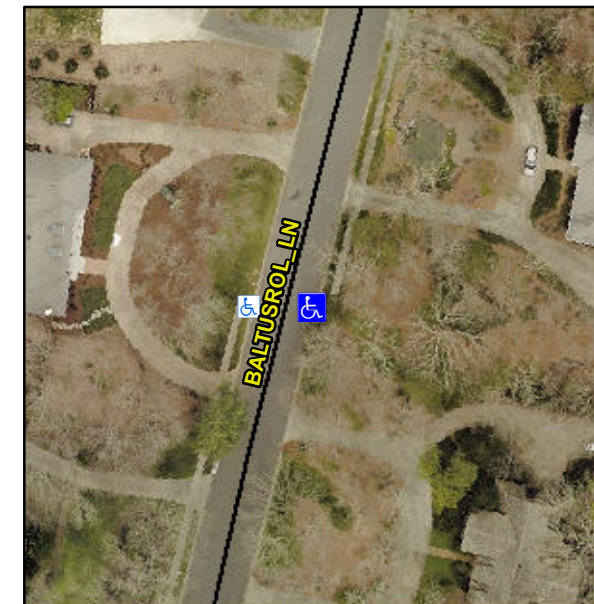
R304.5.1, R304.5.3

Compliance	Description	Data	Compliance	Description	Data
N/A	Ramp Length (in)	50.0	Yes	Ramp Slope (%)	6.7
No	Ramp Width (in)	46.0	No	Ramp XSlope (%)	4.7
N/A	Flare Type LT	N/A	N/A	Flare Type RT	N/A
N/A	Flare Slope LT (%)	N/A	N/A	Flare Slope RT (%)	N/A
N/A	Flare Traversable LT?	No	N/A	Flare Traversable RT?	No
N/A	Landing Length (in)	N/A	N/A	DWS Provided?	N/A
N/A	Landing Width (in)	N/A	N/A	DWS Contrast?	N/A
N/A	Landing Slope (%)	N/A	N/A	DWS Length (in)	N/A
N/A	Landing X Slope (%)	N/A	N/A	DWS Full Width?	N/A
N/A	Landing Curb? (Y/N)	N/A	N/A	DWS Offset (in)	N/A
N/A	Shared Landing?	N/A			
N/A	Gutter Ponding?	N/A	N/A	Gutter Slope (%)	N/A
N/A	Gutter Lip Ht (in)	N/A	N/A	Gutter X Slope (%)	N/A
N/A	Painted X Walk1?	No	N/A	Painted X Walk2?	N/A
	X Walk 1 Direction	To W		X Walk 2 Direction	N/A
N/A	X Walk 1 Width (in)	N/A	N/A	X Walk 2 Width (in)	N/A
	X Walk 1 Slope (%)	5.4		X Walk 2 Slope (%)	N/A
	X Walk 1 X Slope (%)	4.6		X Walk 2 X Slope (%)	N/A

N/A	Ramp inside XWalk1?	N/A	N/A	Ramp inside XWalk2?	N/A
	Road Slope (%)	N/A	N/A	Clear Space?	N/A
	Road X Slope (%)	N/A	N/A	Clear Space to XWalk (in)	N/A
N/A	Any Obstructions?	N/A	N/A	Storm Grate/Utility Hazard?	N/A
	Obstruction Type			Storm Grate/Utility Type	
		N/A			N/A
			Yes	Surface Condition? (G/P)	Good

Remove & Replace Entire Ramp.

Total Cost: \$ 1850.00
