Access Compliance Report Public Rights-of-Way (Curb Ramps)

Intersection ID: 49136 Main Street: AMBER_LEIGH_WAY_DR Cross Street: POPE_FARM_RD Location: W

ADA ID: 8ECF3D7E6D22 Ramp Type: Perpendicular Initial Pass/Fail: Fail Overall Compliance: No Severity Score: 12.5

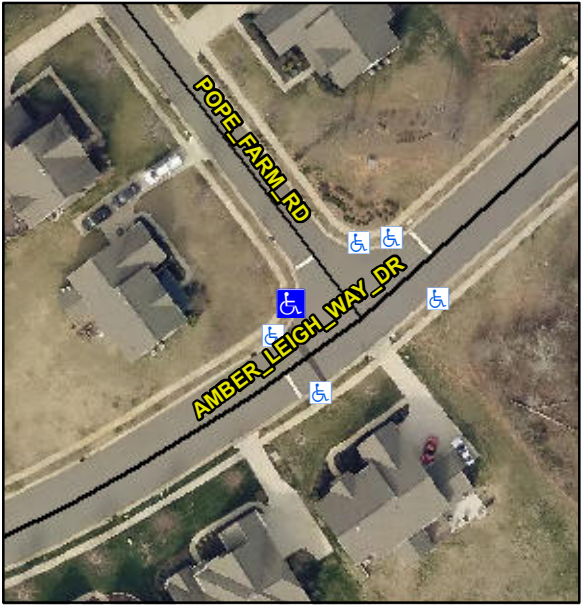
PROW/ADA:
Not Found, R304.2.2

Compliance	Description	Data	Compliance	Description	Data
N/A	Ramp Length (in)	48.0	No	Ramp Slope (%)	8.4
Yes	Ramp Width (in)	48.0	Yes	Ramp XSlope (%)	1.0
N/A	Flare Type LT	N/A	N/A	Flare Type RT	N/A
N/A	Flare Slope LT (%)	N/A	N/A	Flare Slope RT (%)	N/A
N/A	Flare Traversable LT?	N/A	N/A	Flare Traversable RT?	N/A
N/A	Landing Length (in)	N/A	N/A	DWS Provided?	N/A
N/A	Landing Width (in)	N/A	N/A	DWS Contrast?	N/A
N/A	Landing Slope (%)	N/A	N/A	DWS Length (in)	N/A
N/A	Landing X Slope (%)	N/A	N/A	DWS Full Width?	N/A
N/A	Landing Curb? (Y/N)	N/A	N/A	DWS Offset (in)	N/A
N/A	Shared Landing?	N/A			
N/A	Gutter Ponding?	N/A	N/A	Gutter Slope (%)	N/A
N/A	Gutter Lip Ht (in)	N/A	N/A	Gutter X Slope (%)	N/A
N/A	Painted X Walk1?	No	N/A	Painted X Walk2?	N/A
	X Walk 1 Direction	To NE		X Walk 2 Direction	N/A
N/A	X Walk 1 Width (in)	N/A	N/A	X Walk 2 Width (in)	N/A
	X Walk 1 Slope (%)	1.4		X Walk 2 Slope (%)	N/A
	X Walk 1 X Slope (%)	0.7		X Walk 2 X Slope (%)	N/A

N/A	Ramp inside XWalk1?	N/A	N/A	Ramp inside XWalk2?	N/A
	Road Slope (%)	N/A	N/A	Clear Space?	N/A
	Road X Slope (%)	N/A	N/A	Clear Space to XWalk (in)	N/A
N/A	Any Obstructions?	N/A	N/A	Storm Grate/Utility Hazard?	N/A
	Obstruction Type			Storm Grate/Utility Type	
			N/A		N/A
			Yes	Surface Condition? (G/P)	Good

Possible Solutions:
Remove & Replace Entire Ramp.
