## **Access Compliance Report Public Rights-of-Way** (Curb Ramps)

Intersection ID: 14943 Main Street: REMOUNT RD **Cross Street: DUNAVANT ST** Location:

ADA ID: 8ED0361A4D3E Ramp Type: Perpendicular Diagonal Initial Pass/Fail: Fail **Overall Compliance: No Severity Score:** 12.5

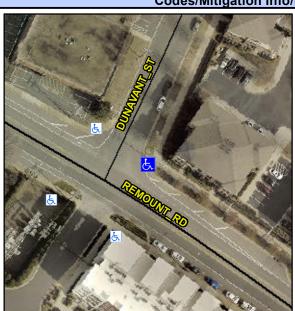
Street 1 Name Stop Condition-Street 2 Street 2 Name Stop Condition-Street 1 **DUNAVANT ST** StopSign **REMOUNT RD** None Possible Solutions: Remove & Replace Curb Ramp With Two New Directional Ramps or Equivalent. Surveyor Notes: N/A PROW/ADA: Not Found, R304.2.2

Compl	iance Description	Data	ta Compliance Description		Data
N/A	Ramp Length (in)	93.0	No	Ramp Slope (%)	8.5
Yes	Ramp Width (in)	73.0	Yes	Ramp XSlope (%)	0.8
N/A	Flare Type LT	N/A	N/A	Flare Type RT	N/A
N/A	Flare Slope LT (%)	N/A	N/A	Flare Slope RT (%)	N/A
N/A	Flare Traversable LT?	N/A	N/A	Flare Traversable RT?	N/A
N/A	Landing Length (in)	N/A	N/A	DWS Provided?	N/A
N/A	Landing Width (in)	N/A	N/A	DWS Contrast?	N/A
N/A	Landing Slope (%)	N/A	N/A	DWS Length (in)	N/A
N/A	Landing X Slope (%)	N/A	N/A	DWS Full Width?	N/A
N/A	Landing Curb? (Y/N)	N/A	N/A	DWS Offset (in)	N/A
N/A	Shared Landing?	N/A			
N/A	Gutter Ponding?	N/A	N/A	Gutter Slope (%)	N/A
N/A	Gutter Lip Ht (in)	N/A	N/A	Gutter X Slope (%)	N/A
N/A	Painted X Walk1?	No	N/A	Painted X Walk2?	No
	X Walk 1 Direction	To NW		X Walk 2 Direction	To SW
N/A	X Walk 1 Width (in)	N/A	N/A	X Walk 2 Width (in)	N/A
	X Walk 1 Slope (%)	0.9		X Walk 2 Slope (%)	0.3
	X Walk 1 X Slope (%)	0.3		X Walk 2 X Slope (%)	0.5
