# Access Compliance Report

## Public Rights-of-Way

### (Curb Ramps)

Intersection ID: 14314	Main Street: TREMONT_ST	Cross Street: SOUTH_BV	Location: NW
ADA ID: 8ED59FD356EF	Ramp Type: Perpendicular	Initial Pass/Fail: Fail	Overall Compliance: No
Codes/Mitigation Info/Possible Solution		Field Measurements/Component Compliance

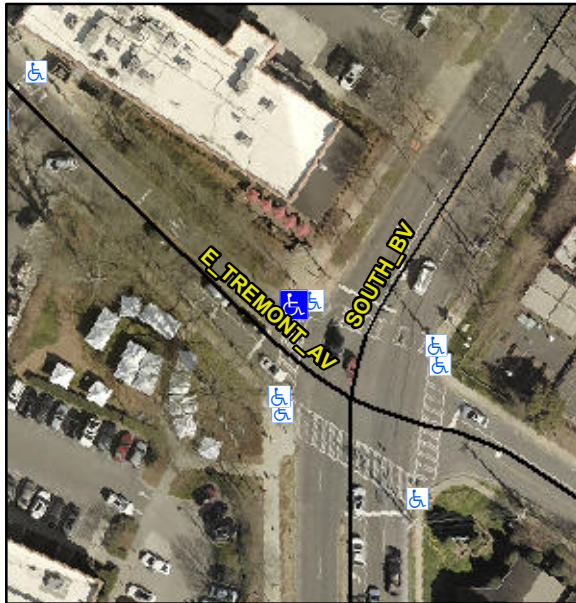
Compliance	Description	Data	Compliance	Description	Data
N/A	Ramp Length (in)	64.0	No	Ramp Slope (%)	9.0
Yes	Ramp Width (in)	48.0	Yes	Ramp XSlope (%)	2.3
N/A	Flare Type LT	N/A	N/A	Flare Type RT	N/A
N/A	Flare Slope LT (%)	N/A	N/A	Flare Slope RT (%)	N/A
N/A	Flare Traversable LT?	N/A	N/A	Flare Traversable RT?	N/A
N/A	Landing Length (in)	N/A	N/A	DWS Provided?	N/A
N/A	Landing Width (in)	N/A	N/A	DWS Contrast?	N/A
N/A	Landing Slope (%)	N/A	N/A	DWS Length (in)	N/A
N/A	Landing X Slope (%)	N/A	N/A	DWS Full Width?	N/A
N/A	Landing Curb? (Y/N)	N/A	N/A	DWS Offset (in)	N/A
N/A	Shared Landing?	N/A			
N/A	Gutter Ponding?	N/A	N/A	Gutter Slope (%)	N/A
N/A	Gutter Lip Ht (in)	N/A	N/A	Gutter X Slope (%)	N/A
N/A	Painted X Walk1?	Yes	N/A	Painted X Walk2?	N/A
	X Walk 1 Direction	To SW		X Walk 2 Direction	N/A
N/A	X Walk 1 Width (in)	121.0	N/A	X Walk 2 Width (in)	N/A
	X Walk 1 Slope (%)	10.3		X Walk 2 Slope (%)	N/A
	X Walk 1 X Slope (%)	2.9		X Walk 2 X Slope (%)	N/A

N/A	Ramp inside XWalk1?	Yes	N/A	Ramp inside XWalk2?	N/A
	Road Slope (%)	N/A	N/A	Clear Space?	N/A
	Road X Slope (%)	N/A	N/A	Clear Space to XWalk (in)	N/A
N/A	Any Obstructions?	N/A	N/A	Storm Grate/Utility Hazard?	N/A
	Obstruction Type			Storm Grate/Utility Type	
		N/A			N/A
		Yes		Surface Condition? (G/P)	Good

Possible Solutions:

**Remove & Replace Entire Ramp.**

PROW/ADA:

**R304.2.2**

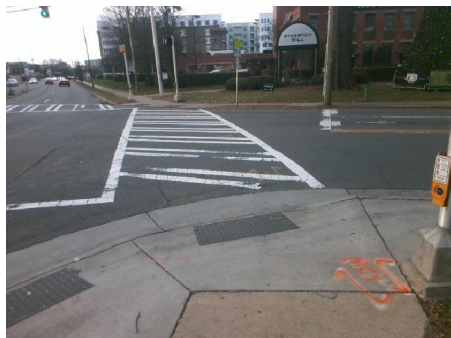
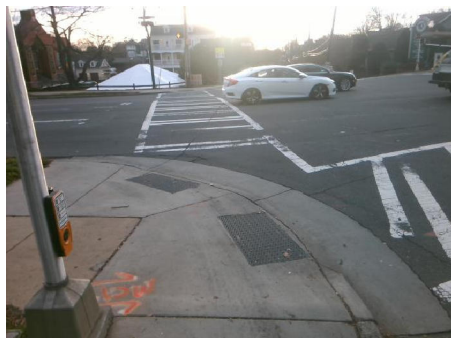
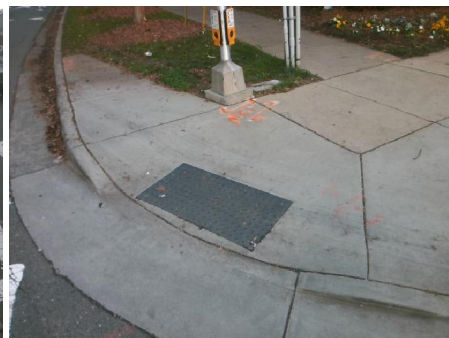
Street 1 Name **E TREMONT AV**

Stop Condition-Street 2 **Signal**
