Access Compliance Report

Public Rights-of-Way

(Curb Ramps)

Intersection ID: 15236	Main Street: CARLING_AV	Cross Street: DILWORTH_RD_EAST	Location: S
ADA ID: 8ED6E1A7DA88	Ramp Type: Perp	Initial Pass/Fail: Fail	Overall Compliance: No
		Severity Score: 10

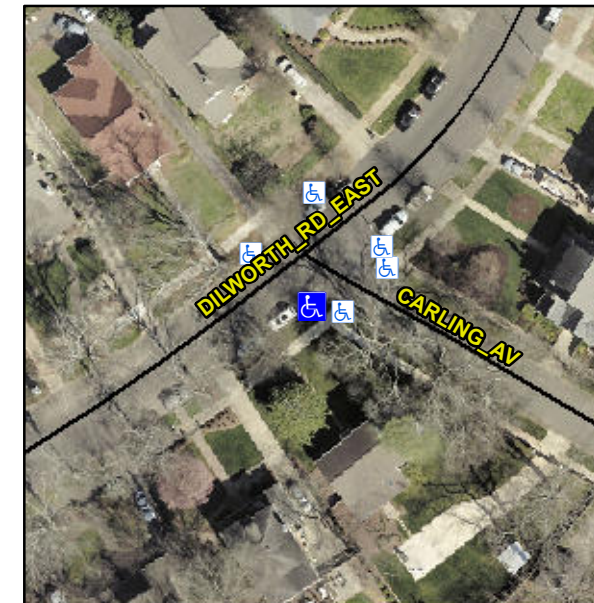
Not Found, R304.5.1, R304.5.3

Compliance	Description	Data	Compliance	Description	Data
N/A	Ramp Length (in)	48.0	Yes	Ramp Slope (%)	7.6
No	Ramp Width (in)	42.0	No	Ramp XSlope (%)	2.5
N/A	Flare Type LT	N/A	N/A	Flare Type RT	N/A
N/A	Flare Slope LT (%)	N/A	N/A	Flare Slope RT (%)	N/A
N/A	Flare Traversable LT?	N/A	N/A	Flare Traversable RT?	N/A
N/A	Landing Length (in)	N/A	N/A	DWS Provided?	N/A
N/A	Landing Width (in)	N/A	N/A	DWS Contrast?	N/A
N/A	Landing Slope (%)	N/A	N/A	DWS Length (in)	N/A
N/A	Landing X Slope (%)	N/A	N/A	DWS Full Width?	N/A
N/A	Landing Curb? (Y/N)	N/A	N/A	DWS Offset (in)	N/A
N/A	Shared Landing?	N/A			
N/A	Gutter Ponding?	N/A	N/A	Gutter Slope (%)	N/A
N/A	Gutter Lip Ht (in)	N/A	N/A	Gutter X Slope (%)	N/A
N/A	Painted X Walk1?	No	N/A	Painted X Walk2?	N/A
	X Walk 1 Direction	To NW		X Walk 2 Direction	N/A
N/A	X Walk 1 Width (in)	N/A	N/A	X Walk 2 Width (in)	N/A
	X Walk 1 Slope (%)	6.2		X Walk 2 Slope (%)	N/A
	X Walk 1 X Slope (%)	0.3		X Walk 2 X Slope (%)	N/A

N/A	Ramp inside XWalk1?	N/A	N/A	Ramp inside XWalk2?	N/A
	Road Slope (%)	N/A	N/A	Clear Space?	N/A
	Road X Slope (%)	N/A	N/A	Clear Space to XWalk (in)	N/A
N/A	Any Obstructions?	N/A	N/A	Storm Grate/Utility Hazard?	N/A
	Obstruction Type			Storm Grate/Utility Type	
		N/A			N/A
			Yes	Surface Condition? (G/P)	Good

Remove & Replace Entire Ramp.
