Access Compliance Report

Public Rights-of-Way

(Curb Ramps)

| ADA ID: 8EF2002B421B | Ramp Type: Perpendicular Diagonal | Initial Pass/Fail: Pass | Overall Compliance: No |

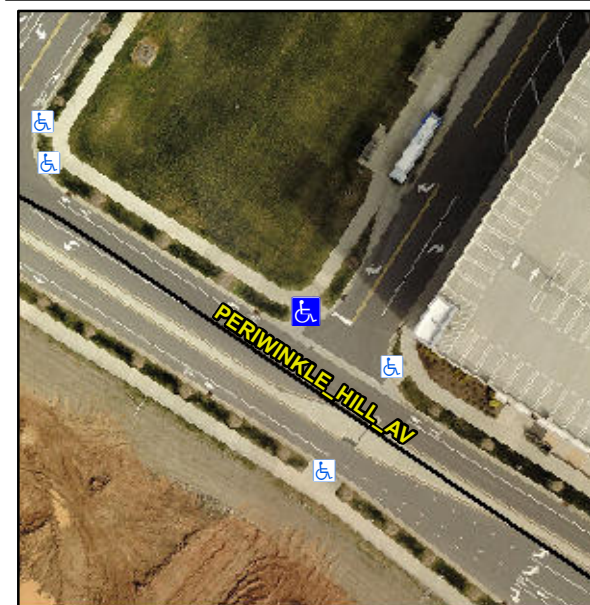
Not Found, R304.5.3

| Compliance | Description | Data | Compliance | Description | Data |
|---|---|---|---|---|---|
| Yes | Ramp Width (in) | 48.0 | No | Ramp XSlope (%) | 4.2 |
| No | Landing X Slope (%) | 4.1 | Yes | DWS Full Width? | Yes |

Remove & Replace Curb Ramp With Two New Directional Ramps or Equivalent.

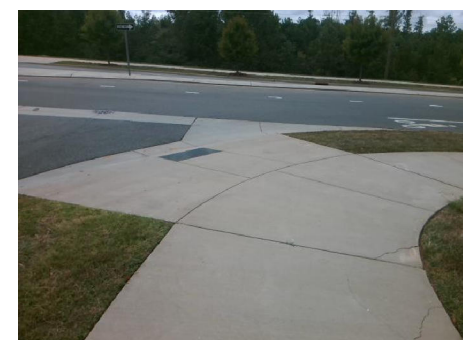
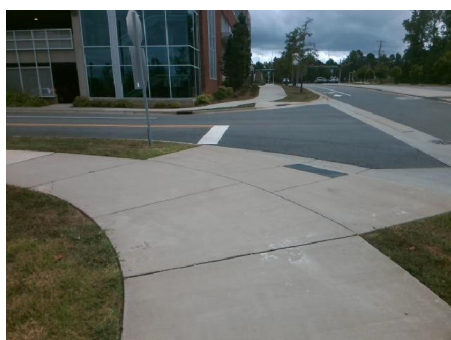
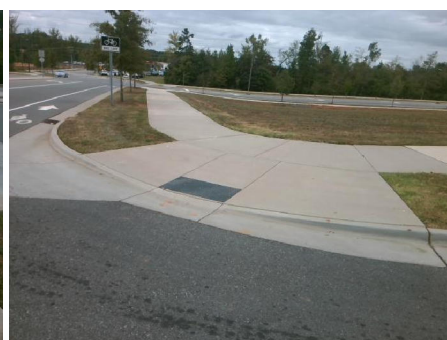
| Compliance | Description | Data | Compliance | Description | Data |
|---|---|---|---|---|---|
| | | | Yes | Surface Condition? (G/P) | Good |
