# Access Compliance Report

## Public Rights-of-Way

### (Curb Ramps)

Intersection ID: 16403	Main Street: CRAIG_AV	Cross Street: EASTVIEW_DR	Location:	N
ADA ID: 8EFF79D2DF1C	Ramp Type: Perpendicular Diagonal	Initial Pass/Fail: Fail	Overall Compliance: No	Severity Score: 31.25

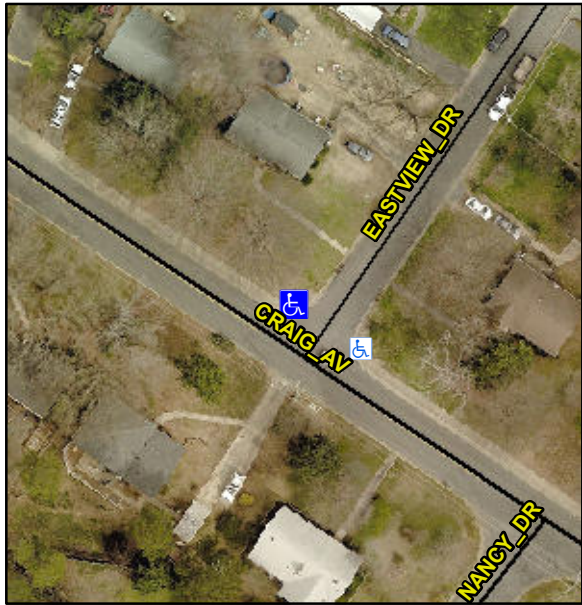
Possible Solutions:		Compliance	Description	Data	Compliance	Description	Data
	<b>Remove &amp; Replace Curb Ramp With Two New Directional Ramps or Equivalent.</b>		N/A	Ramp Length (in)	61.0	No	Ramp Slope (%)	10.5
			No	Ramp Width (in)	35.0	No	Ramp XSlope (%)	2.2
			N/A	Flare Type LT	N/A	N/A	Flare Type RT	N/A
			N/A	Flare Slope LT (%)	N/A	N/A	Flare Slope RT (%)	N/A
			N/A	Flare Traversable LT?	N/A	N/A	Flare Traversable RT?	N/A
			N/A	Landing Length (in)	N/A	N/A	DWS Provided?	N/A
			N/A	Landing Width (in)	N/A	N/A	DWS Contrast?	N/A
			N/A	Landing Slope (%)	N/A	N/A	DWS Length (in)	N/A
			N/A	Landing X Slope (%)	N/A	N/A	DWS Full Width?	N/A
Surveyor Notes:			N/A	Landing Curb? (Y/N)	N/A	N/A	DWS Offset (in)	N/A
<b>N/A</b>			N/A	Shared Landing?	N/A			
PROW/ADA:			N/A	Gutter Ponding?	N/A	N/A	Gutter Slope (%)	N/A
<b>Not Found, R304.5.1, R304.2.2, R304.5.3</b>			N/A	Gutter Lip Ht (in)	N/A	N/A	Gutter X Slope (%)	N/A

N/A	Painted X Walk1?	No	N/A	Painted X Walk2?	No
				X Walk 1 Direction	To SW		X Walk 2 Direction	To SE
			N/A	X Walk 1 Width (in)	N/A	N/A	X Walk 2 Width (in)	N/A
				X Walk 1 Slope (%)	7.1		X Walk 2 Slope (%)	0.6
				X Walk 1 X Slope (%)	0.9		X Walk 2 X Slope (%)	1.4
			N/A	Ramp inside XWalk1?	N/A	N/A	Ramp inside XWalk2?	N/A
				Road Slope (%)	2.3	N/A	Clear Space?	N/A
				Road X Slope (%)	2.9	N/A	Clear Space to XWalk (in)	N/A
			N/A	Any Obstructions?	N/A	N/A	Storm Grate/Utility Hazard?	N/A
				Obstruction Type			Storm Grate/Utility Type	
						N/A		N/A
						Yes	Surface Condition? (G/P)	Good
