Access Compliance Report

Public Rights-of-Way

(Curb Ramps)

Intersection ID: 23966	Main Street: CAROLINA PAVILION DR N	Cross Street: SOUTH BV	Location: NW
ADA ID: 8F0CEBE3B9E9	Ramp Type: Perpendicular	Initial Pass/Fail: Fail	Overall Compliance: No
Severity Score: 13.75			
Codes/Mitigation Info/Possible Solution		Field Measurements/Component Compliance

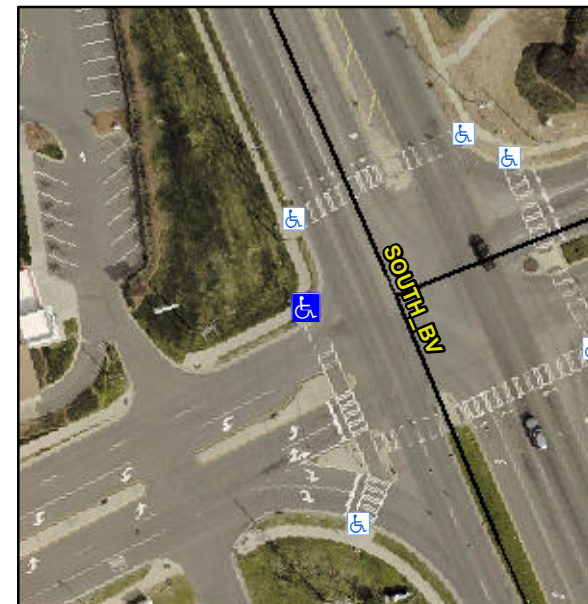
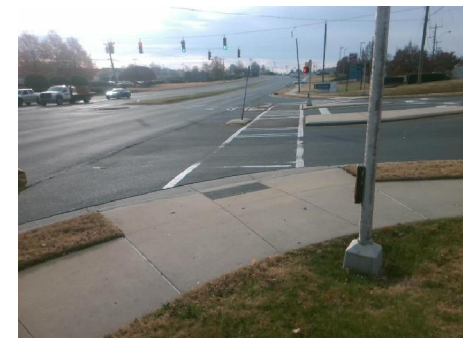
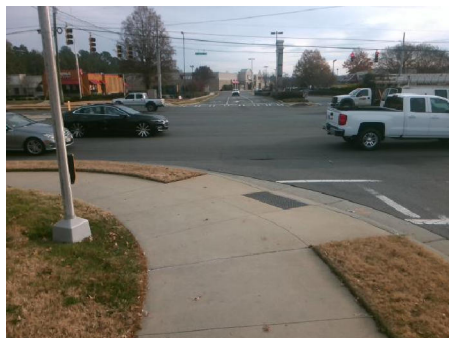
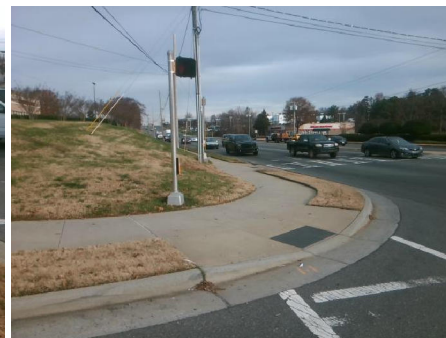
Not Found, R304.2.2

Compliance	Description	Data	Compliance	Description	Data
N/A	Ramp Length (in)	48.0	No	Ramp Slope (%)	8.6
Yes	Ramp Width (in)	48.0	Yes	Ramp XSlope (%)	3.2
N/A	Flare Type LT	N/A	N/A	Flare Type RT	N/A
N/A	Flare Slope LT (%)	N/A	N/A	Flare Slope RT (%)	N/A
N/A	Flare Traversable LT?	N/A	N/A	Flare Traversable RT?	N/A
N/A	Landing Length (in)	N/A	N/A	DWS Provided?	N/A
N/A	Landing Width (in)	N/A	N/A	DWS Contrast?	N/A
N/A	Landing Slope (%)	N/A	N/A	DWS Length (in)	N/A
N/A	Landing X Slope (%)	N/A	N/A	DWS Full Width?	N/A
N/A	Landing Curb? (Y/N)	N/A	N/A	DWS Offset (in)	N/A
N/A	Shared Landing?	N/A			
N/A	Gutter Ponding?	N/A	N/A	Gutter Slope (%)	N/A
N/A	Gutter Lip Ht (in)	N/A	N/A	Gutter X Slope (%)	N/A
N/A	Painted X Walk1?	Yes	N/A	Painted X Walk2?	N/A
	X Walk 1 Direction	To S		X Walk 2 Direction	N/A
N/A	X Walk 1 Width (in)	98.0	N/A	X Walk 2 Width (in)	N/A
	X Walk 1 Slope (%)	1.9		X Walk 2 Slope (%)	N/A
	X Walk 1 X Slope (%)	3.8		X Walk 2 X Slope (%)	N/A

N/A	Ramp inside XWalk1?	Yes	N/A	Ramp inside XWalk2?	N/A
	Road Slope (%)	N/A	N/A	Clear Space?	N/A
	Road X Slope (%)	N/A	N/A	Clear Space to XWalk (in)	N/A
N/A	Any Obstructions?	N/A	N/A	Storm Grate/Utility Hazard?	N/A
	Obstruction Type			Storm Grate/Utility Type	
		N/A			N/A
			Yes	Surface Condition? (G/P)	Good

Possible Solutions:

Remove & Replace Entire Ramp.

Total Cost: \$ 1850.00
