Access Compliance Report Public Rights-of-Way (Curb Ramps)

Intersection ID: 14645 Main Street: DILWORTH_RD_WEST Cross Street: E_PARK_AV Location: W

ADA ID: 8F292A10DDF4 Ramp Type: Perpendicular Diagonal Initial Pass/Fail: Fail Overall Compliance: No Severity Score: 50

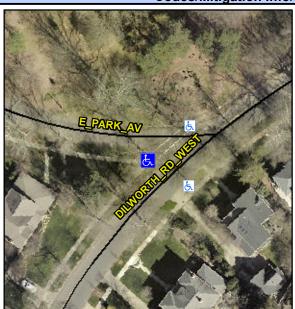
Compli	iance Description	Data	Compli	ance Description	Data
N/A	Ramp Length (in)	57.0	No	Ramp Slope (%)	18.8
Yes	'es Ramp Width (in)		No	Ramp XSlope (%)	7.4
N/A	N/A Flare Type LT		N/A	Flare Type RT	N/A
N/A Flare Slope LT (%)		N/A	N/A	Flare Slope RT (%)	N/A
N/A	N/A Flare Traversable LT?		N/A	Flare Traversable RT?	N/A
N/A	N/A Landing Length (in)		N/A	DWS Provided?	N/A
N/A	N/A Landing Width (in)		N/A	DWS Contrast?	N/A
N/A	Landing Slope (%)	N/A	N/A	DWS Length (in)	N/A
N/A	Landing X Slope (%)	N/A	N/A	DWS Full Width?	N/A
N/A	Landing Curb? (Y/N)	N/A	N/A	DWS Offset (in)	N/A
N/A	Shared Landing?	N/A			
N/A	Gutter Ponding?	Yes	N/A	Gutter Slope (%)	N/A
N/A	Gutter Lip Ht (in)	N/A	N/A	Gutter X Slope (%)	N/A
N/A	Painted X Walk1?	No	N/A	Painted X Walk2?	Yes
	X Walk 1 Direction	To SE		X Walk 2 Direction	To NE
N/A	X Walk 1 Width (in)	N/A	N/A	X Walk 2 Width (in)	90.0
	X Walk 1 Slope (%)	2.9		X Walk 2 Slope (%)	3.3
	X Walk 1 X Slope (%)	2.3		X Walk 2 X Slope (%)	0.4

N/A	Ramp inside XWalk1?	N/A	N/A	Ramp inside XWalk2?	Yes
	Road Slope (%)	0.5	N/A	Clear Space?	N/A
	Road X Slope (%)	2.9	N/A	Clear Space to XWalk (in)	N/A
N/A	Any Obstructions?	N/A	N/A	Storm Grate/Utility Hazard?	N/A
	Obstruction Type			Storm Grate/Utility Type

Remove & Replace Curb Ramp With Two New Directional Ramps or Equivalent.

R304.2.2, R304.5.3
