# Access Compliance Report

## Public Rights-of-Way

| Intersection ID: 30015 | Main Street: MOORGATE_RD | Cross Street: YEARWOOD_LN | Location: SW |
| ADA ID: 8F389C383866 | Ramp Type: Perpendicular Diagonal | Initial Pass/Fail: Fail | Overall Compliance: No |

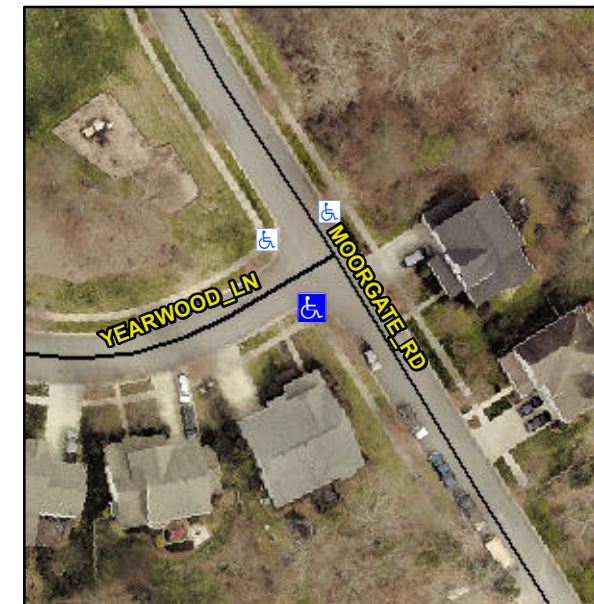
| | | Severity Score: 8.75 | |

**Not Found, R304.5.1**

| Compliance | Description | Data | Compliance | Description | Data |
|---|---|---|---|---|---|
| N/A | Ramp Length (in) | 69.0 | Yes | Ramp Slope (%) | 6.1 |
| No | Ramp Width (in) | 37.0 | Yes | Ramp XSlope (%) | 1.8 |
| N/A | Gutter Lip Ht (in) | 2.0 | N/A | Gutter X Slope (%) | N/A |

**Remove & Replace Curb Ramp With Two New Directional Ramps or Equivalent.**

Total Cost: \$ 3200.00
