Access Compliance Report

Public Rights-of-Way

(Curb Ramps)

Intersection ID: 21348	Main Street: CARMEL_RD	Cross Street: SHARON_VIEW_RD	Location: SE
ADA ID: 8F399CACAD05	Ramp Type: Perpendicular	Initial Pass/Fail: Fail	Overall Compliance: No
		Severity Score: 26.25

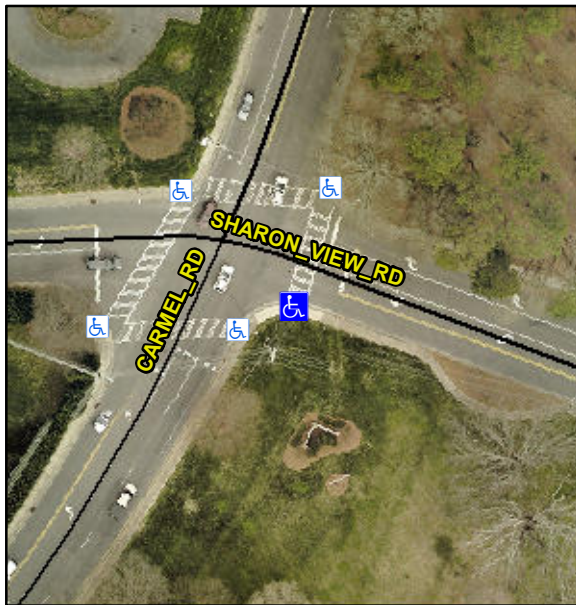
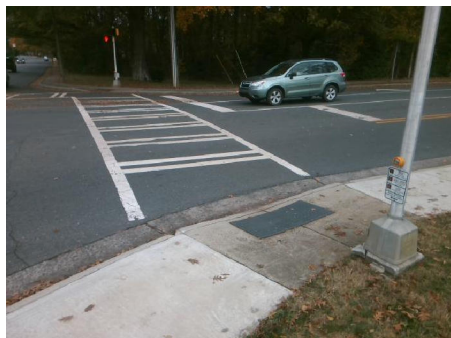
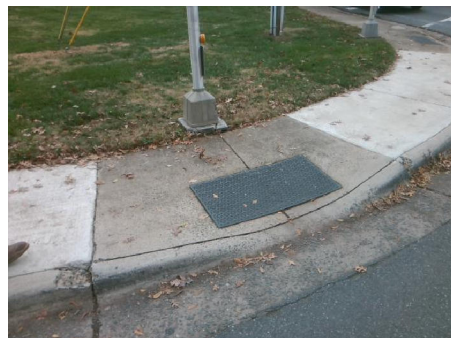
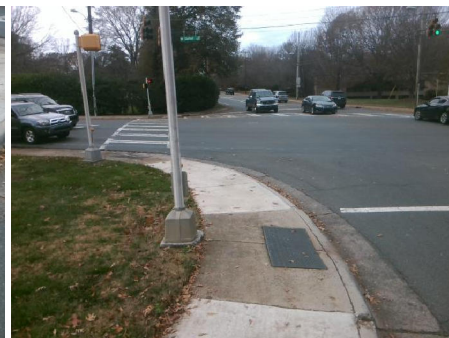
Not Found, R304.2.2, R304.5.3

Compliance	Description	Data	Compliance	Description	Data
N/A	Ramp Length (in)	62.0	No	Ramp Slope (%)	12.6
Yes	Ramp Width (in)	48.0	No	Ramp XSlope (%)	3.9
N/A	Flare Type LT	N/A	N/A	Flare Type RT	N/A
N/A	Flare Slope LT (%)	N/A	N/A	Flare Slope RT (%)	N/A
N/A	Flare Traversable LT?	N/A	N/A	Flare Traversable RT?	N/A
N/A	Landing Length (in)	N/A	N/A	DWS Provided?	N/A
N/A	Landing Width (in)	N/A	N/A	DWS Contrast?	N/A
N/A	Landing Slope (%)	N/A	N/A	DWS Length (in)	N/A
N/A	Landing X Slope (%)	N/A	N/A	DWS Full Width?	N/A
N/A	Landing Curb? (Y/N)	N/A	N/A	DWS Offset (in)	N/A
N/A	Shared Landing?	N/A			
N/A	Gutter Ponding?	N/A	N/A	Gutter Slope (%)	N/A
N/A	Gutter Lip Ht (in)	N/A	N/A	Gutter X Slope (%)	N/A
N/A	Painted X Walk1?	Yes	N/A	Painted X Walk2?	N/A
	X Walk 1 Direction	To NE		X Walk 2 Direction	N/A
N/A	X Walk 1 Width (in)	111.0	N/A	X Walk 2 Width (in)	N/A
	X Walk 1 Slope (%)	5.8		X Walk 2 Slope (%)	N/A
	X Walk 1 X Slope (%)	1.3		X Walk 2 X Slope (%)	N/A

N/A	Ramp inside XWalk1?	Yes	N/A	Ramp inside XWalk2?	N/A
	Road Slope (%)	N/A	N/A	Clear Space?	N/A
	Road X Slope (%)	N/A	N/A	Clear Space to XWalk (in)	N/A
N/A	Any Obstructions?	N/A	N/A	Storm Grate/Utility Hazard?	N/A
	Obstruction Type			Storm Grate/Utility Type	
		N/A			N/A
			Yes	Surface Condition? (G/P)	Good

Remove & Replace Entire Ramp.
