Access Compliance Report

Public Rights-of-Way

(Curb Ramps)

Intersection ID: 5987	Main Street: OAK_DR	Cross Street: OAKBLUFF_CR	Location: W
ADA ID: 8F45E56EEBBA	Ramp Type: Perpendicular	Initial Pass/Fail: Fail	Overall Compliance: No
		Severity Score: 12.5

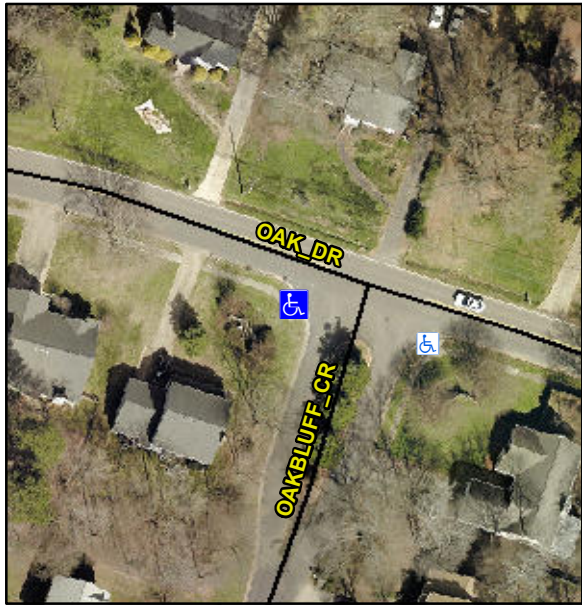
Possible Solutions:		Compliance	Description	Data	Compliance	Description	Data
	Remove & Replace Entire Ramp.		N/A	Ramp Length (in)	100.0	Yes	Ramp Slope (%)	5.3
			Yes	Ramp Width (in)	48.5	No	Ramp XSlope (%)	6.5
			N/A	Flare Type LT	N/A	N/A	Flare Type RT	N/A
			N/A	Flare Slope LT (%)	N/A	N/A	Flare Slope RT (%)	N/A
			N/A	Flare Traversable LT?	N/A	N/A	Flare Traversable RT?	N/A
			N/A	Landing Length (in)	N/A	N/A	DWS Provided?	N/A
			N/A	Landing Width (in)	N/A	N/A	DWS Contrast?	N/A
			N/A	Landing Slope (%)	N/A	N/A	DWS Length (in)	N/A
			N/A	Landing X Slope (%)	N/A	N/A	DWS Full Width?	N/A
Surveyor Notes:		N/A	N/A	Landing Curb? (Y/N)	N/A	N/A	DWS Offset (in)	N/A
PROW/ADA:		Not Found, R304.5.3	N/A	Shared Landing?	N/A			
			N/A	Gutter Ponding?	N/A	N/A	Gutter Slope (%)	N/A
			N/A	Gutter Lip Ht (in)	N/A	N/A	Gutter X Slope (%)	N/A

N/A	Painted X Walk1?	No	N/A	Painted X Walk2?	N/A
				X Walk 1 Direction	To SE		X Walk 2 Direction	N/A
			N/A	X Walk 1 Width (in)	N/A	N/A	X Walk 2 Width (in)	N/A
				X Walk 1 Slope (%)	0.5		X Walk 2 Slope (%)	N/A
				X Walk 1 X Slope (%)	6.2		X Walk 2 X Slope (%)	N/A
Street 1 Name		OAKBLUFF CR	N/A	Ramp inside XWalk1?	N/A	N/A	Ramp inside XWalk2?	N/A
Stop Condition-Street 2		StopSign		Road Slope (%)	N/A	N/A	Clear Space?	N/A
Street 2 Name		N/A		Road X Slope (%)	N/A	N/A	Clear Space to XWalk (in)	N/A
Stop Condition-Street 1		N/A	N/A	Any Obstructions?	N/A	N/A	Storm Grate/Utility Hazard?	N/A
				Obstruction Type			Storm Grate/Utility Type	
					N/A			N/A
						Yes	Surface Condition? (G/P)	Good
Total Cost:		\$ 1850.00
